APPENDIX 2

Aquatic Ecology

Figure 1: Overview of the $n=40$ aquatic survey locations for the proposed Ballinagree wind farm project, Co. Cork.

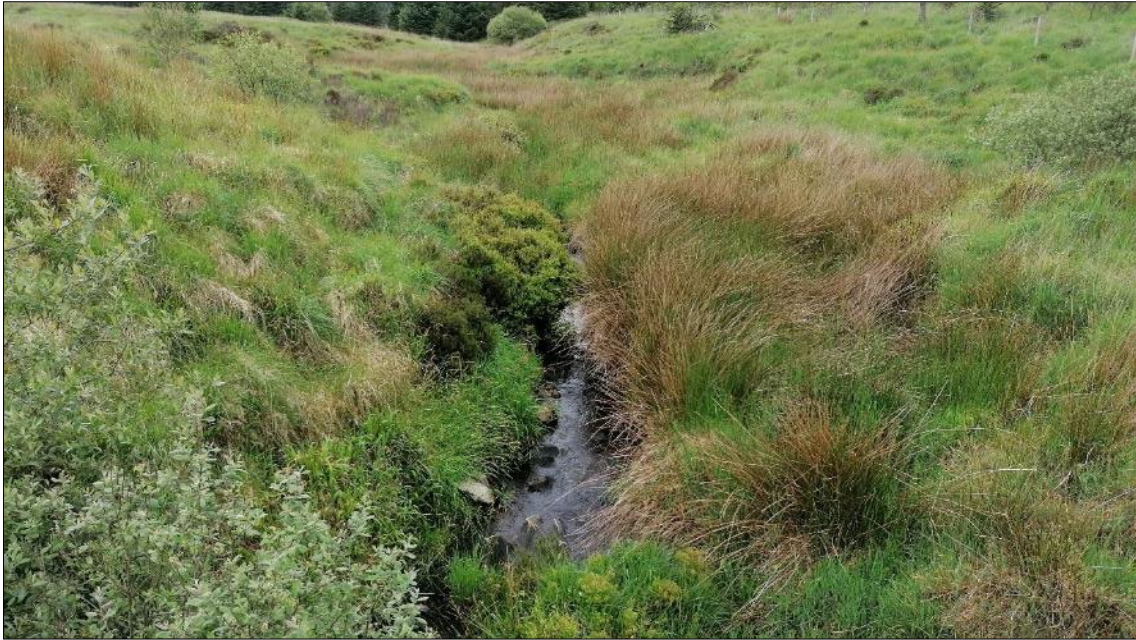
Site A1 was located on the uppermost reaches of the Nadanuller Beg Stream (EPA code: 18N05, also known locally as the Owenaluggin River). The upland eroding watercourse (FW1) was characterised by glide and riffle sequences with localised pool habitat over boulder cascades. The channel was approximately 1m wide and 0.2m deep with peat-stained water at the time of survey. The deep U-shaped channel graded into a valley with shallow slopes adjoining upland conifer plantations (WD4, 10-15 years old). The substrata were dominated by bedrock (20%), boulder (30%), large cobble (20%) and peat, with only localised coarse and medium gravels. The substrata were moderately silted and featured a very high coverage of filamentous algae at the time of survey. The adjoining lands comprised of wet grassland (GS4), blanket bog and pockets of heath, with purple moor grass (*Molinia caerulea*), *Juncus* sp. rushes and marsh bedstraw (*Galium palustre*) dominating. Macrophytes were absent due to the high energy of the site. However, aquatic bryophyte coverage was high locally, with *Fontinalis squamosa* and common earwort (*Scapania undulata*) present on boulder tops.

Biological water quality, based on Q-sampling, was calculated as Q4 (good status) (Table 6). Molybdate reactive phosphorus (MRP) (0.043mg P/l) and total ammonia (0.094mg N/l) concentrations were high and, thus, the site failed meet the good status thresholds as set out under S.I. No. 77/2019 - European Union Environmental Objectives (Surface Waters) (Amendment) Regulations 2019 (Table 9).

Plate 1: Representative image of site A1 on the Nadanuller Beg Stream, June 2020 (facing upstream)

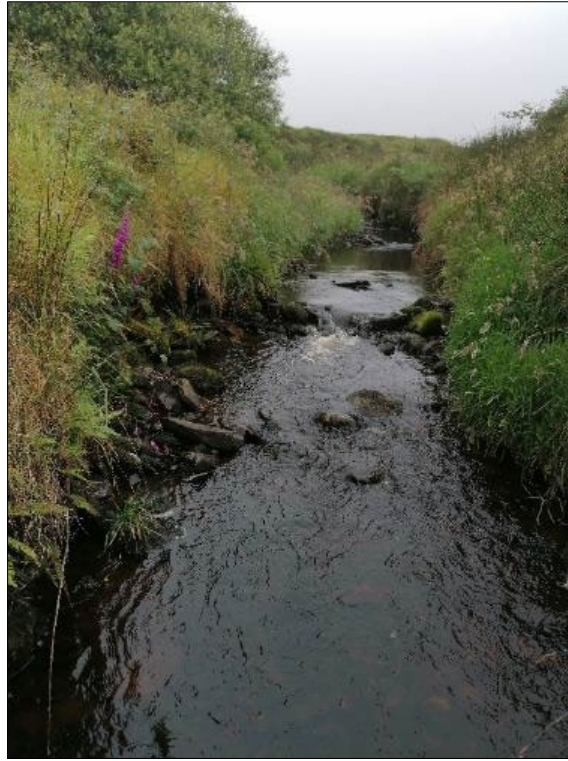
Brown trout (*Salmo trutta*) was the only fish species recorded from site A2 via electro-fishing. The site was considered an excellent trout nursery, with the population dominated by juveniles. Spawning habitat was good, locally, although deeper holding habitat for adults was sparse (as were adult fish themselves). The small, high-energy stream was considered of low value to European eel and was unsuitable for lamprey. There was no suitability for freshwater pearl mussel. No white-clawed crayfish were recorded and there were no records for the species within the catchment. No otter signs were recorded during the survey and the site was considered of low suitability given its small size and upland nature.

Biological water quality, based on Q-sampling, was calculated as Q4 (good status) (Table 6).

Plate 2: Representative image of site A2 on the Nadanuller Beg Stream, July 2020

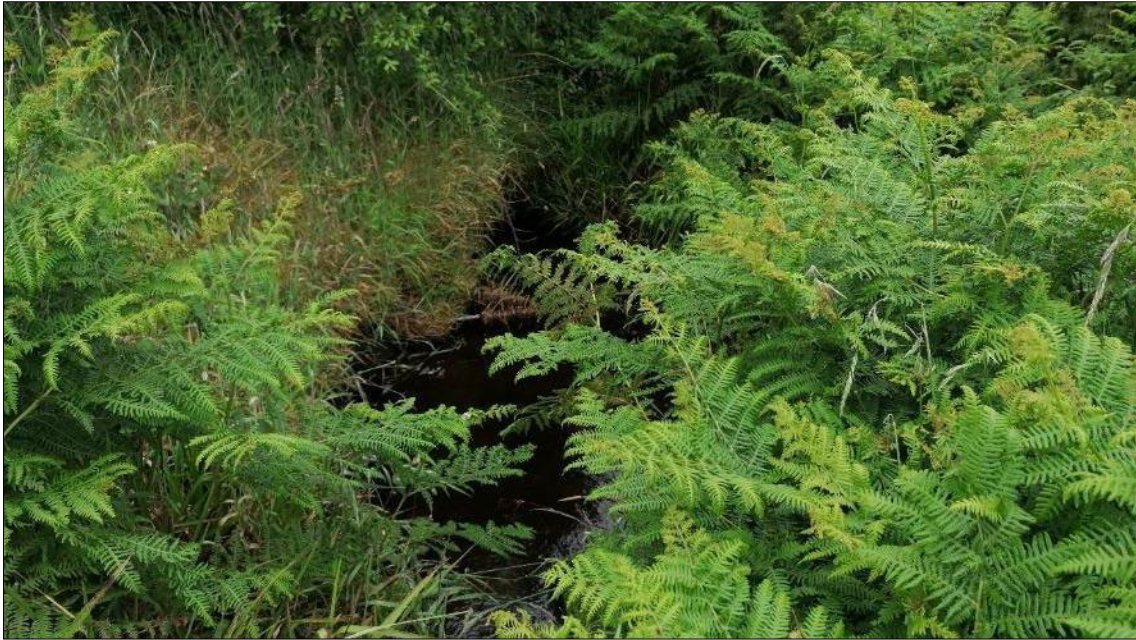
Brown trout was the only fish species recorded from site A3 via electro-fishing. Low numbers of adult trout were recorded, with an absence of juveniles. The site was considered of moderate value for salmonids, overall. The small, high-energy stream was considered of low value to European eel (none recorded) and was unsuitable for lamprey. There was no suitability for freshwater pearl mussel. No white-clawed crayfish were recorded and there were no records for the species within the catchment. No otter signs were recorded during the survey and the site was considered of low suitability given its small size and upland nature.

Biological water quality was not assessed at this site.

Plate 3: Representative image of site A3 on an unnamed stream at Crinaloo South, July 2020

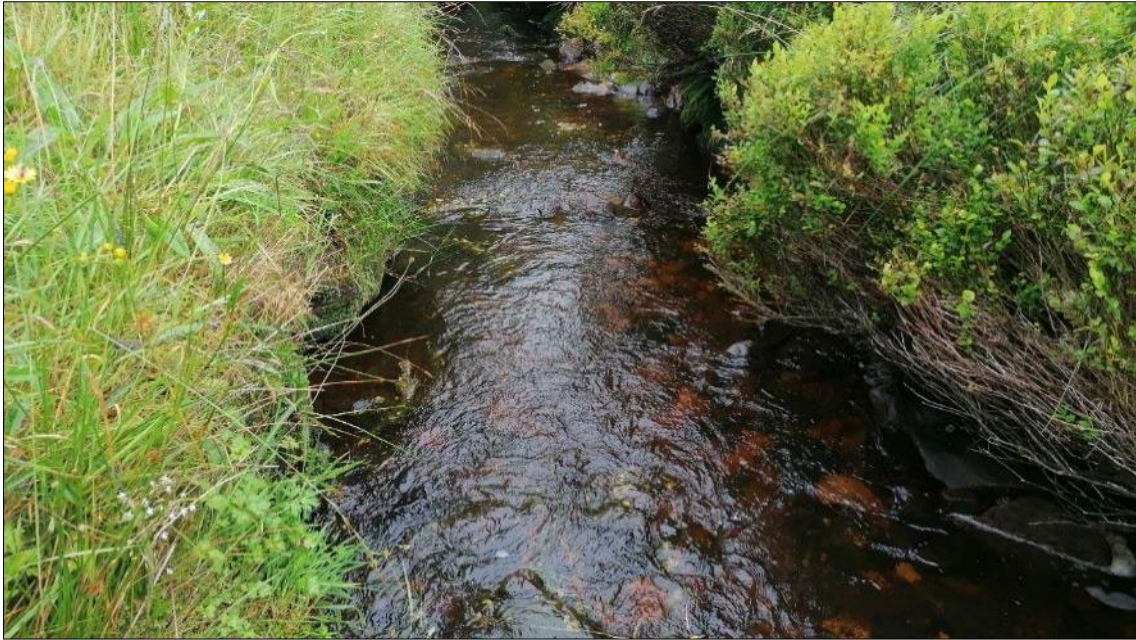
Brown trout and European eel (*Anguilla anguilla*) were the only two fish species recorded from site A4 via electro-fishing. Trout were present in moderate numbers, with both adults and a low number of juveniles present. A single adult eel was also recorded. The river was considered a moderate nursery with moderate quality spawning locally. Holding habitat was also considered moderate. Eel habitat was moderate overall but the high-energy site was considered unsuitable for lamprey. There was no suitability for freshwater pearl mussel. No white-clawed crayfish were recorded and there were no records for the species within the catchment. No otter signs were recorded during the survey and the site was considered of low suitability given its small size and upland nature.

Plate 4: Representative image of site A4 on an unnamed stream at Crinaloo South, July 2020

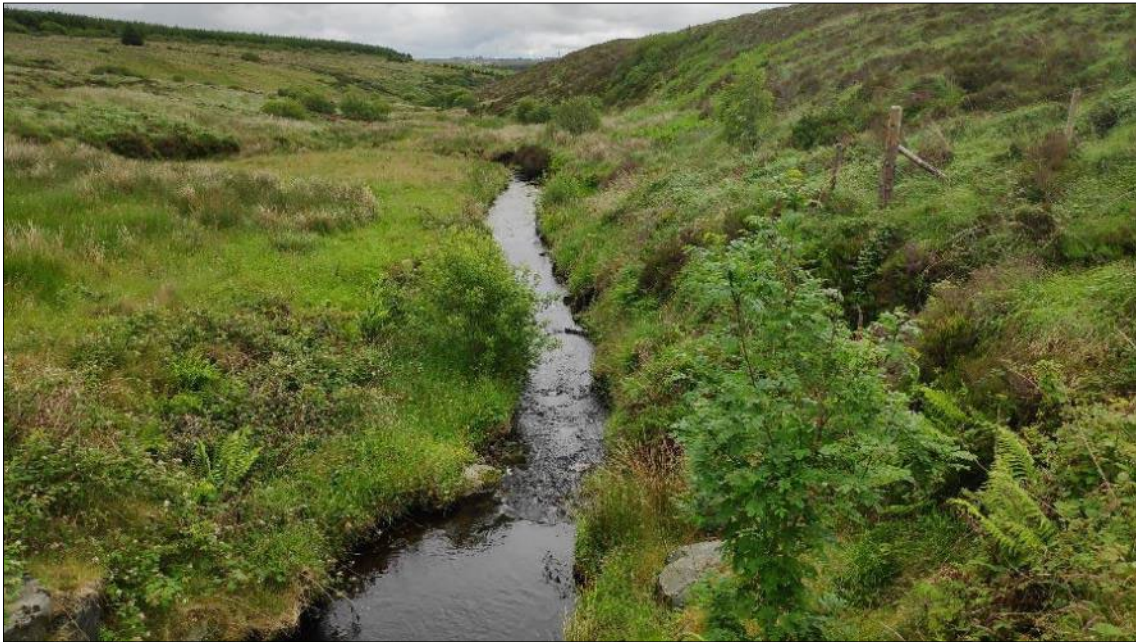
Site A5 on the upper reaches of the Glen River (EPA code: 18G04) (bridge crossing CC-L95791-005.00) was an upland eroding watercourse (FW1) characterised by glide and riffle sequences with localised pool habitat over boulder cascades. The channel averaged 2m wide and 0.3m deep with peat-stained water at the time of survey. The shallow U-shaped channel was cut into a shallow sloping valley. The site drained an upland area which featured frequent coniferous afforestation (WD4). The adjoining lands comprised heath (south bank) and wet grassland with pockets of heath to the north. The riparian zone featured open banks with low lying cover of soft rush (*Juncus effusus*), ferns, common sorrel (*Rumex acetosa*), bramble (*Rubus fruticosus* agg.), foxglove (*Digitalis purpurea*), heather (*Calluna vulgaris*), purple moor grass, rank grasses and occasional willow and rowan (*Sorbus aucuparia*). The substrata were dominated by boulder (30%), large cobble (40%) with coarse and medium gravels (20%). The remaining proportions comprised silt and small pockets of finer gravel in interstitial spaces, with a concrete apron near the bridge. The substrata were heavily covered with floc and filamentous algae. Macrophytes were not present upstream but downstream slower glide supported small beds of water crowfoot vegetation (*Ranunculus* sp.). The site had a high coverage of *Fontinalis squamosa* and *Chiloscyphus polyanthos*, with common earwort and yellow fringe moss also present. The presence of more than three indicator macrophyte/bryophyte species means the site's aquatic vegetative community was representative of the Annex I habitat 'Water courses of plain to montane levels with the Ranunculion fluitantis and Callitricho-Batrachion vegetation and aquatic mosses [3260]'.

Site A5 was located within the Boggeragh Mountains NHA (0002447), a site designated for peatlands. This site was therefore considered of national importance. The site also supported good-quality salmonid habitat, the presence of Annex I 'floating river vegetation' habitat and good status (Q4) water quality.

Plate 5: Representative image of site A5 on the Glen River (facing downstream from bridge)

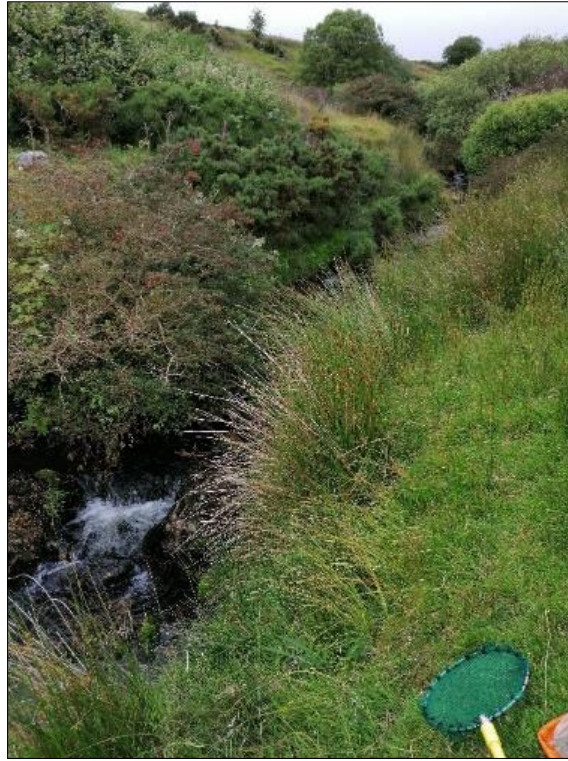
Brown trout was the only fish species recorded from site B1 via electro-fishing. Trout were present in low numbers, with only small adults recorded. Despite this, nursery habitat was moderate overall, with locally good spawning habitat present. However, the high-energy, steep-gradient of the site reduced the fisheries value considerably. The site was of limited value for eel and considered unsuitable for lamprey. There was no suitability for freshwater pearl mussel. No white-clawed crayfish were recorded and there were no records for the species within the catchment. No otter signs were recorded during the survey and the site was considered of low suitability given its small size and upland nature. No otter signs were recorded during the survey and the site was considered of low suitability given its small size and upland nature.

Plate 6: Representative image of site B1 on the Carrigagulla Stream, July 2020

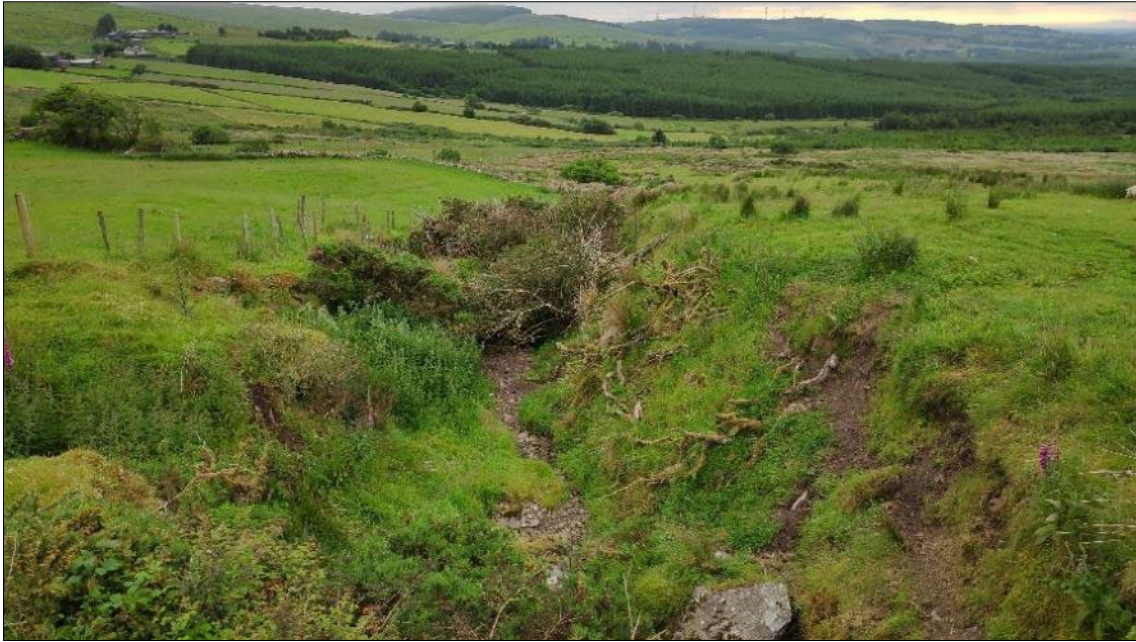
The stream offered no fisheries value at the time of survey (100% dry) and was considered to offer little if any fisheries value when conveying water given its small, high-gradient, high-energy upland nature. The site had no potential for freshwater pearl mussel or white-clawed crayfish given the seasonal, upland nature of the stream. No otter signs were recorded during the survey and the site was considered of low suitability given its small size and upland nature. No otter signs were recorded during the survey and the site was considered of low suitability given its small size and upland nature.

Plate 7: Representative image of site B2 on the upper reaches of an unnamed stream at Knocknagappul (site 100% dry during the survey period)

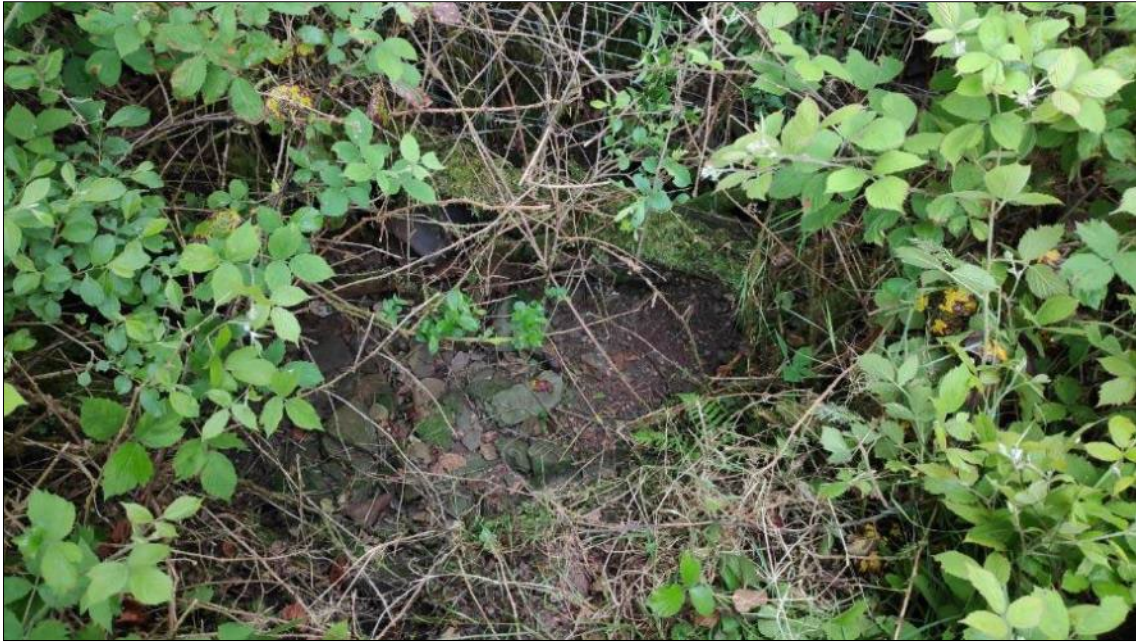
The stream offered no fisheries value at the time of survey (100% dry) and was considered to offer little if any fisheries value when conveying water given its small, high-gradient, high-energy upland nature. The site had no potential for freshwater pearl mussel, white-clawed crayfish or otter given the seasonal, upland nature of the stream.

It was not possible to assess biological water quality at this site given a lack of water and flow.

Plate 8: Representative image of site B3 on the West Ballynagree Stream (100% dry during the survey period)

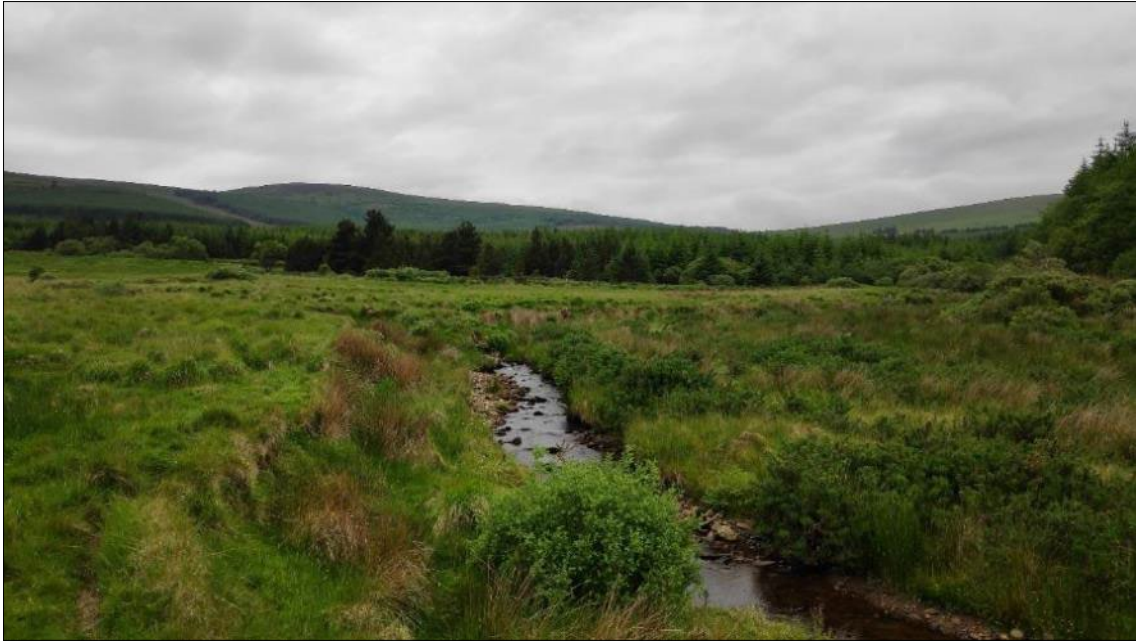
Site B4 was located on the lower reaches of the Knocknagappal Stream (EPA code: 19K04, approx. 50m upstream of the confluence with the River Laney). The natural upland eroding watercourse (FW1) averaged 1-1.5m wide and 0.1-0.2m deep in a deeply cut (near vertical-sided) U-shaped channel. Shallow glide and riffle dominated the site (40% each) with only localised plunge pools, some to 1m in depth but mostly shallower. Bankfull heights were 1.5-2m and the channel evidently conveyed significantly more water during spate conditions. Natural bank scouring was frequent, particularly on the many meanders at the site. The substrata were dominated by small cobble (40%) with occasional small boulder (5%). Fine to medium gravels were frequent (30% overall), with sand also present (10%). Some exposed peat was present locally. Although some silt plumes were present underfoot, overall siltation levels were low in this high-energy channel. The stream meandered through a valley floor with mosaics of lowland blanket bog (PB4) and degraded raised bog (PB1). Common plant species included purple moor grass, soft rush, heath milkwort (*Polygala serpyllifolia*), marsh lousewort (*Pedicularis palustris*), tormentil (*Potentilla erecta*) bog myrtle (*Myrica gale*) and localised bog cotton (*Eriophorum angustifolium*). The area was exposed to low intensity sheep grazing and the bank of the stream were open, with low-height scrub and rank grasses. There was no instream macrophyte growth given the typically high energy of the site (spate channel). The bryophyte community was also poorly represented with only very limited drab brook moss (*Hygrohypnum luridum*) on instream boulders.

Plate 9: Representative image of site B4 on the Knocknagappul Stream (facing upstream from near River Laney confluence).

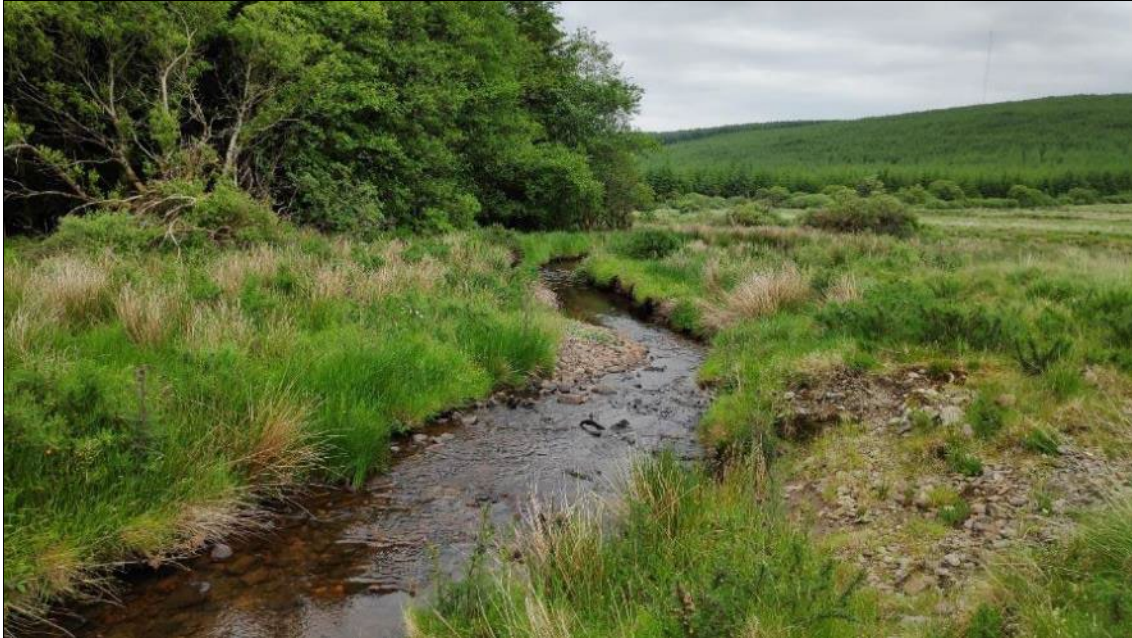
The Laney at site B5 was not considered of any value to lamprey given the high-energy nature. There was low suitability for freshwater pearl mussel and none are known from the River Laney. No white-clawed crayfish were recorded and there were no records for the species within the catchment. No otter signs were recorded during the survey and the site was considered of low suitability given its upland nature.

Plate 10: Representative image of site B5 on the River Laney (facing downstream)

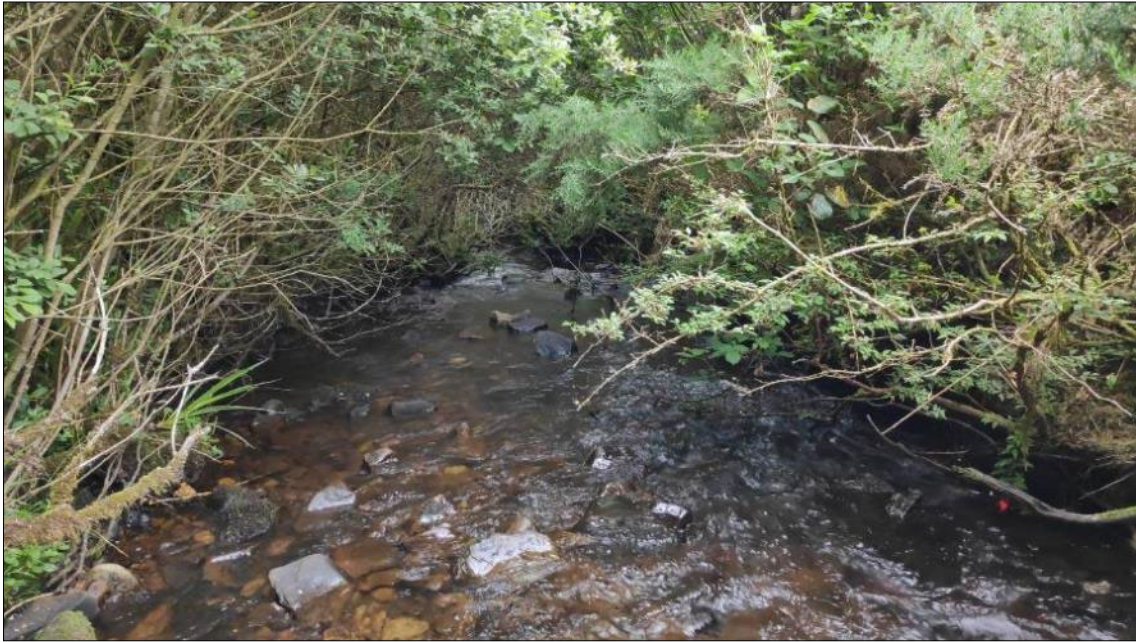
The site was considered a good salmonid habitat overall, with good quality spawning and moderate nursery habitat present, although deeper holding areas were scarce. European eel habitat was considered moderate (none recorded) but the value was reduced given the paucity of larger boulder refugia and deep pools. The high-energy upland site was unsuitable for lamprey. There was low suitability for freshwater pearl mussel and none are known from the River Laney. No white-clawed crayfish were recorded and there were no records for the species within the catchment. No otter signs were recorded during the survey and the site was considered of low suitability given its upland nature.

Biological water quality, based on Q-sampling, was calculated as Q4 (good status) (Table 6).

Plate 11: Representative image of site B6 on the River Laney (facing downstream)

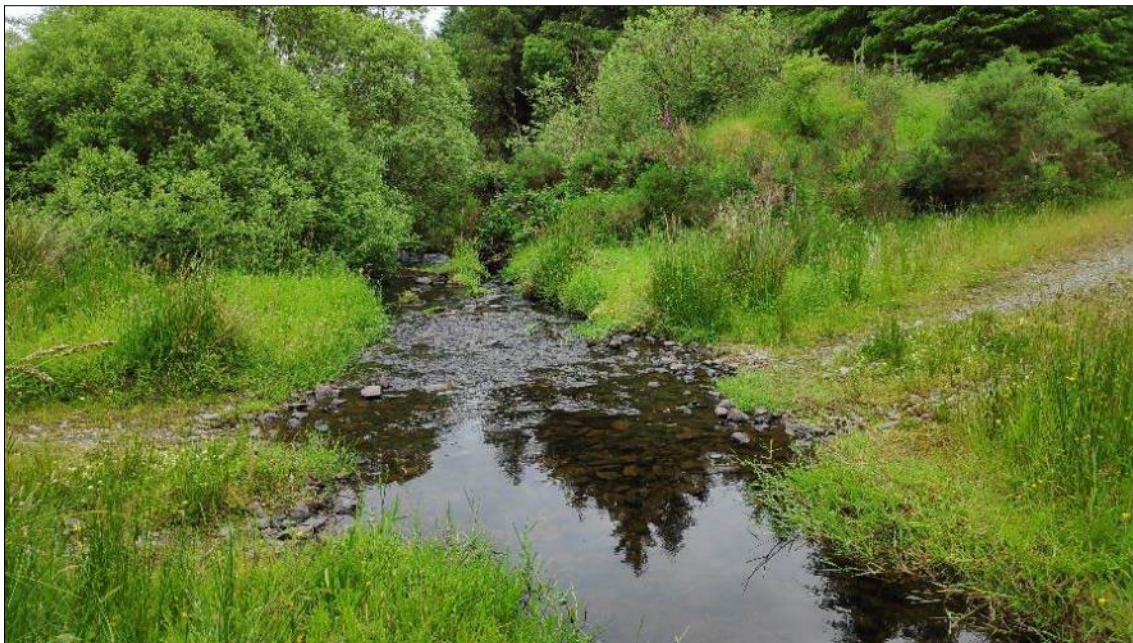
Brown trout was the only fish species recorded from site B7 via electro-fishing, with a low number of adults and juveniles present. The site was considered to have moderate nursery and spawning value for salmonids that would have been higher if not bordered by conifers (abundant pine needle deposition on bed and sedimentation visible). Holding habitat was moderate at best. European eel habitat was considered moderate but none were recorded. The high-energy upland site was unsuitable for lamprey. There was no suitability for freshwater pearl mussel. No white-clawed crayfish were recorded and there were no records for the species within the catchment. No otter signs were recorded during the survey and the site was considered of low suitability given its upland nature.

Biological water quality, based on Q-sampling (June 2021), was calculated as Q4-5 (high status) (Table 8).

Plate 12: Representative image of site B7 on an unnamed stream at Ballynagree East (at forestry track ford crossing and watercourse crossing WF-HF9)

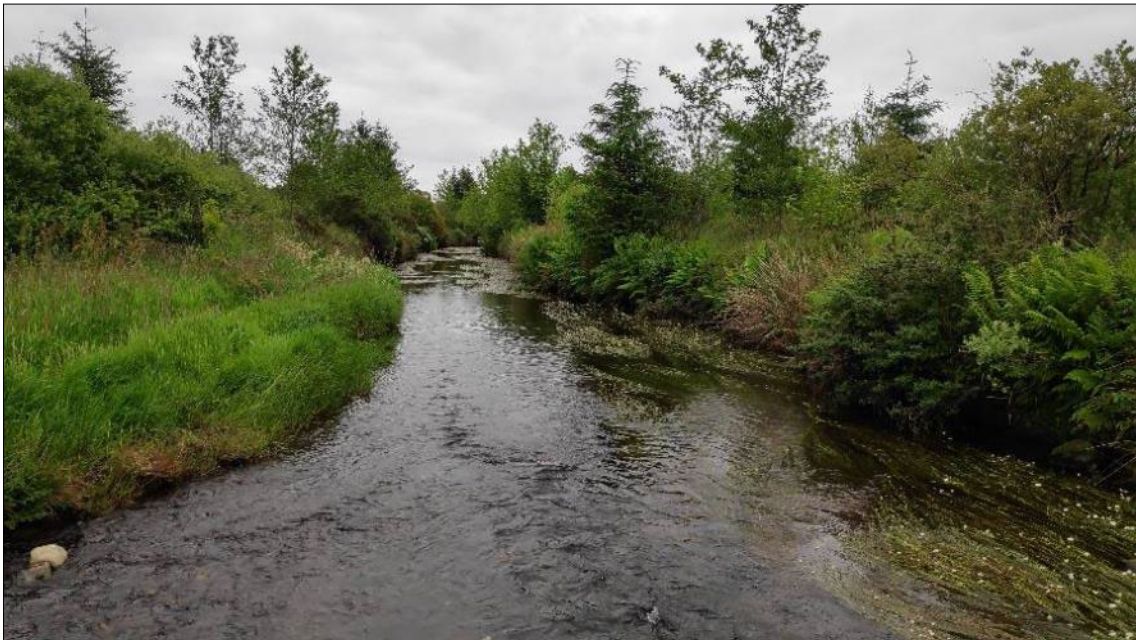
Brown trout and European eel were the only fish species recorded from site B8 via electro-fishing. The trout population was dominated by adults although smaller numbers of juveniles were present also. A single adult eel was also captured. The site was considered a very good nursery and spawning area. It was also a very good holding habitat given the presence of deeper glide and pool. Despite a moderate value for lamprey (localised sediment accumulations) none were recorded. Despite good suitability for freshwater pearl mussel, none were recorded at this site. No white-clawed crayfish were recorded and there were no records for the species within the catchment. No otter signs were recorded during the survey and the site was considered of low suitability given its upland nature.

Biological water quality was not assessed at this site. Biological water quality, based on Q-sampling, was calculated as Q4 (good status) (Table 6).

Plate 13: Representative image of site B8 on the River Laney (facing downstream from ford crossing)

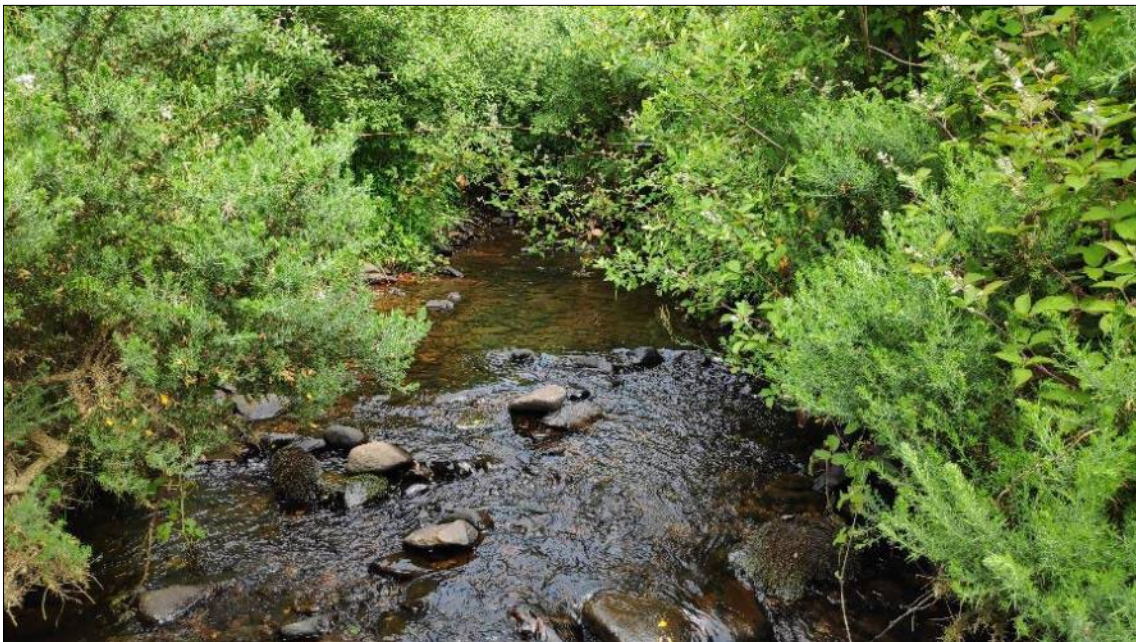
Brown trout and European eel were the only fish species recorded from site B9 via electro-fishing. The trout population was dominated by juveniles. A single juvenile eel was also captured. The site was considered a good salmonid nursery with moderate quality spawning (diminished because of heavily bedded substrata). Holding habitat also considered moderate locally (a small number of deeper pools present). Eel habitat was of moderate quality. The high-energy upland site was unsuitable for lamprey. There was no suitability for freshwater pearl mussel. No white-clawed crayfish were recorded and there were no records for the species within the catchment. No otter signs were recorded during the survey and the site was considered of low suitability given its small size and upland nature.

Biological water quality, based on Q-sampling, was calculated as **Q4-5 (high status)** (Table 6).

Plate 14: Representative image of site B9 on an unnamed stream at Carrigagulla

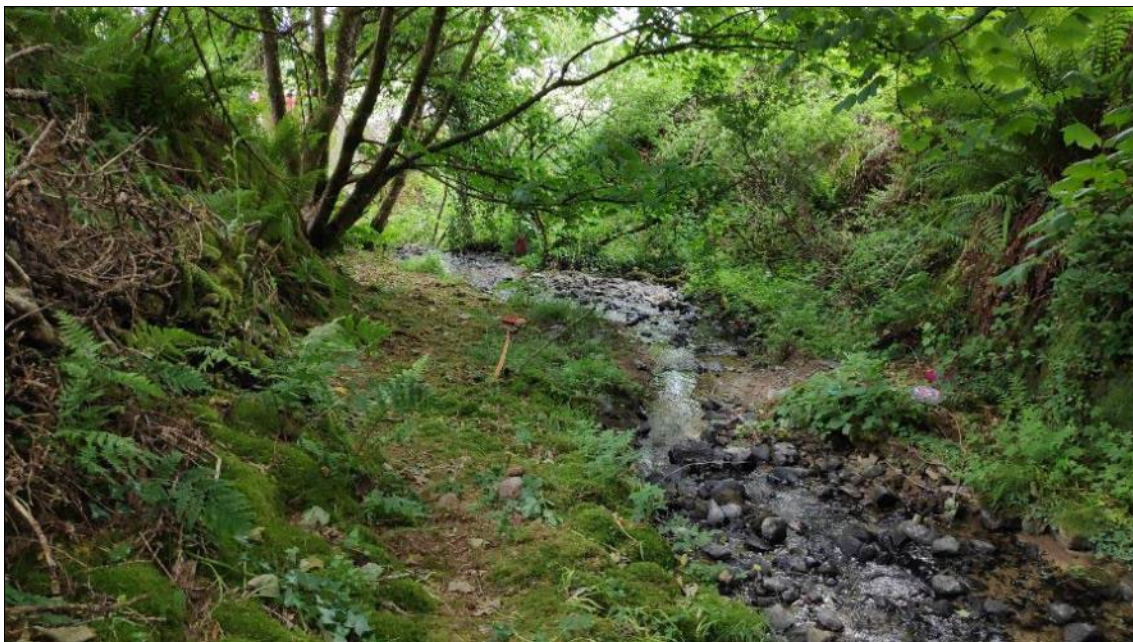
Biological water quality, based on Q-sampling, was calculated as Q4 (good status) (Table 6). The site failed to meet the EPA nitrate threshold for good status water quality (i.e., very high TON of 2.299mg N/l) (Table 9).

Plate 15: Representative image of site B10 on the Ballynagree East Stream

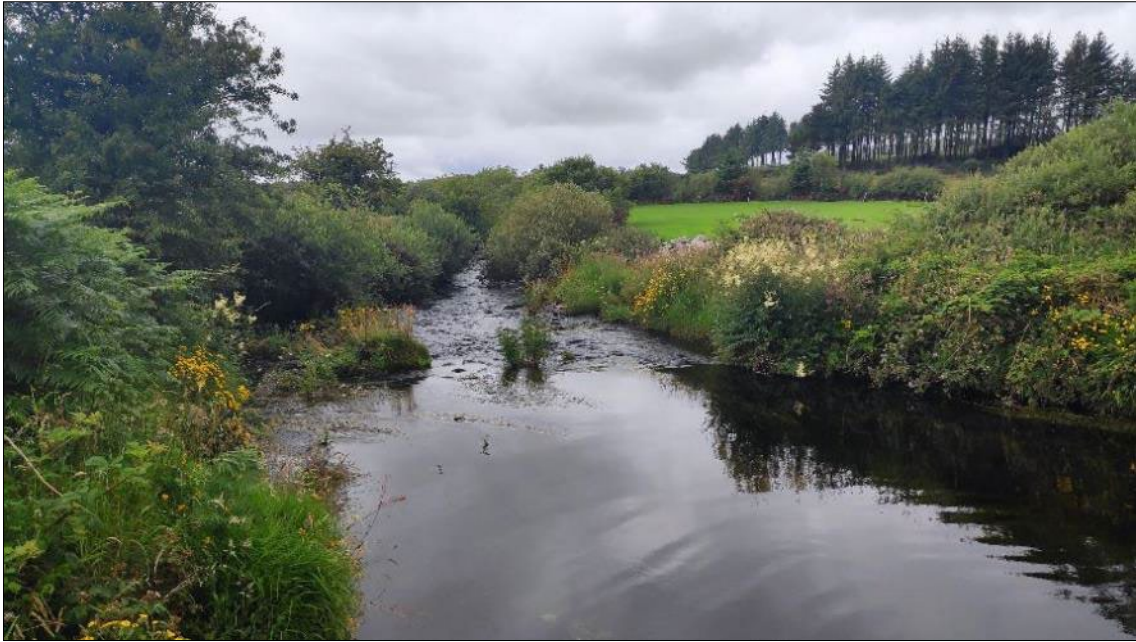
Brown trout was the only fish species recorded from site B11 via electro-fishing, with juveniles and adults present in moderate numbers. The site was a very good brown trout nursery, with moderate (locally good) spawning and some good (locally excellent) holding habitat. Instream macrophyte beds bolstered the nursery value of the site. European eel habitat was considered good throughout given undercut banks, ample boulder refugia and frequent pools although none were recorded. The high energy nature of the site precluded the presence of lamprey. There was low suitability for freshwater pearl mussel. No white-clawed crayfish were recorded and there were no records for the species within the catchment. No otter signs were recorded during the survey but the site was considered of moderate suitability.

Biological water quality, based on Q-sampling, was calculated as Q4 (good status) (Table 6).

Plate 16: Representative image of site B11 on the River Laney (facing downstream from Annaginnihy Stream confluence)

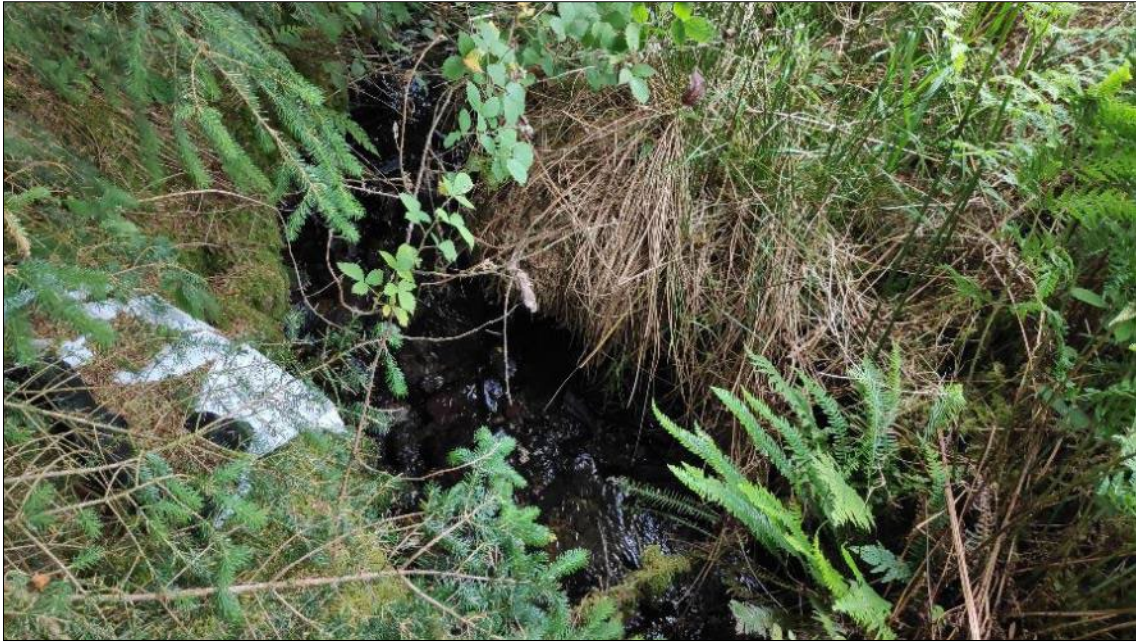
No fish species were recorded from site C1 via electro-fishing. The small, shallow possible seasonal site offered poor fisheries habitat overall, for both salmonids and eel. However, fisheries value improved significantly downstream (i.e., site C3). There was no suitability for lamprey, freshwater pearl mussel or otter given the site characteristics. No white-clawed crayfish were recorded and there were no records for the species within the catchment.

Plate 17: Representative image of site C1 on the Carrigthomas Stream, Knocknagappul

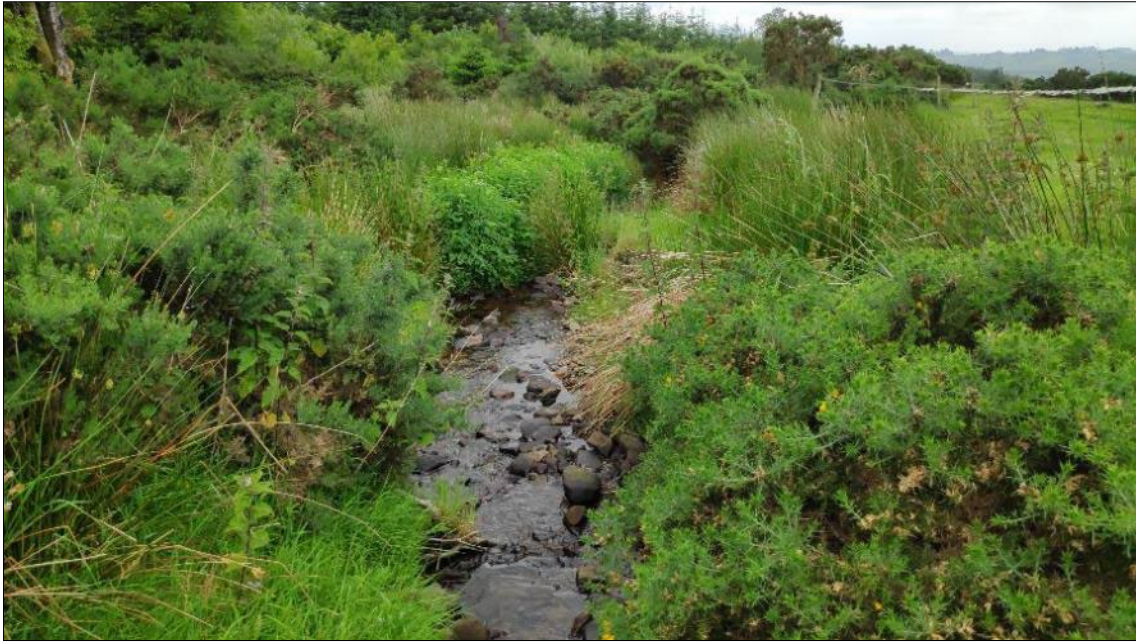
No fish species were recorded from site C2 via electro-fishing. The narrow, shallow site was considered likely non-perennial which, despite some suitability as a salmonid nursery, precluded resident fish. There was no suitability for freshwater pearl mussel given the site characteristics. No white-clawed crayfish were recorded and there were no records for the species within the catchment. No otter signs were recorded during the survey and the site was considered of low suitability given its small size and upland nature.

Plate 18: Representative image of site C2 on the Maulnahorna Stream (downstream of bridge)

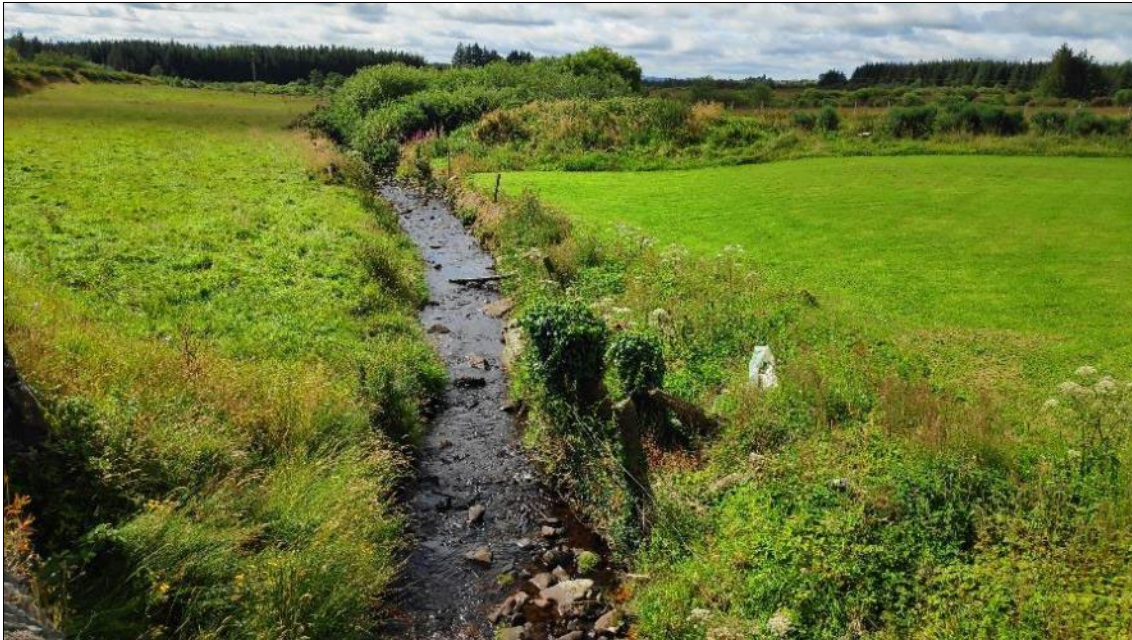
The high energy nature of the site precluded the presence of lamprey. There was no suitability for freshwater pearl mussel. No white-clawed crayfish were recorded and there were no records for the species within the catchment. No otter signs were recorded during the survey and the site was considered of low suitability given its small size and upland nature.

Biological water quality, based on Q-sampling, was calculated as Q4 (good status) (Table 7).

Plate 19: Representative image of site C3 on the Carrigthomas Stream (facing downstream from Horsemount Bridge)

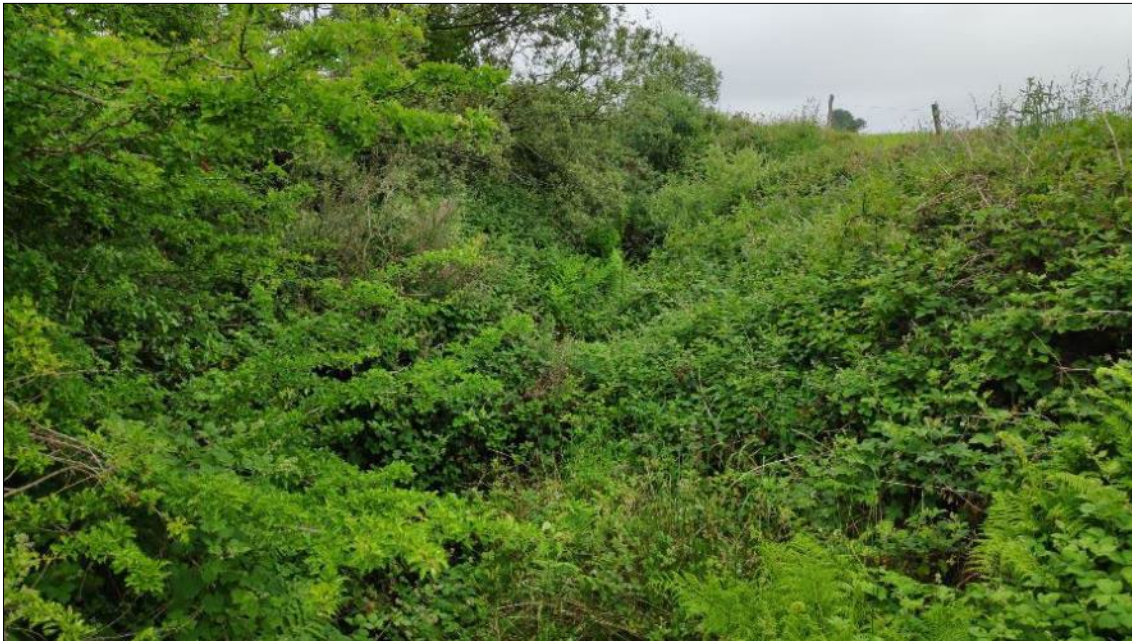
No fish were recorded via electro-fishing. Overall, the stream offered little fisheries value given the extremely shallow and overgrown nature of the channel. However, fisheries habitat improved in the downstream-connecting Carrigthomas Stream, underneath the local road crossing. There was no suitability for freshwater pearl mussel or otter given the site characteristics. No white-clawed crayfish were recorded and there were no records for the species within the catchment.

Plate 20: Representative image of site C4 on the Rahalisk Stream, Knocknagappul (heavily bound in scrub)

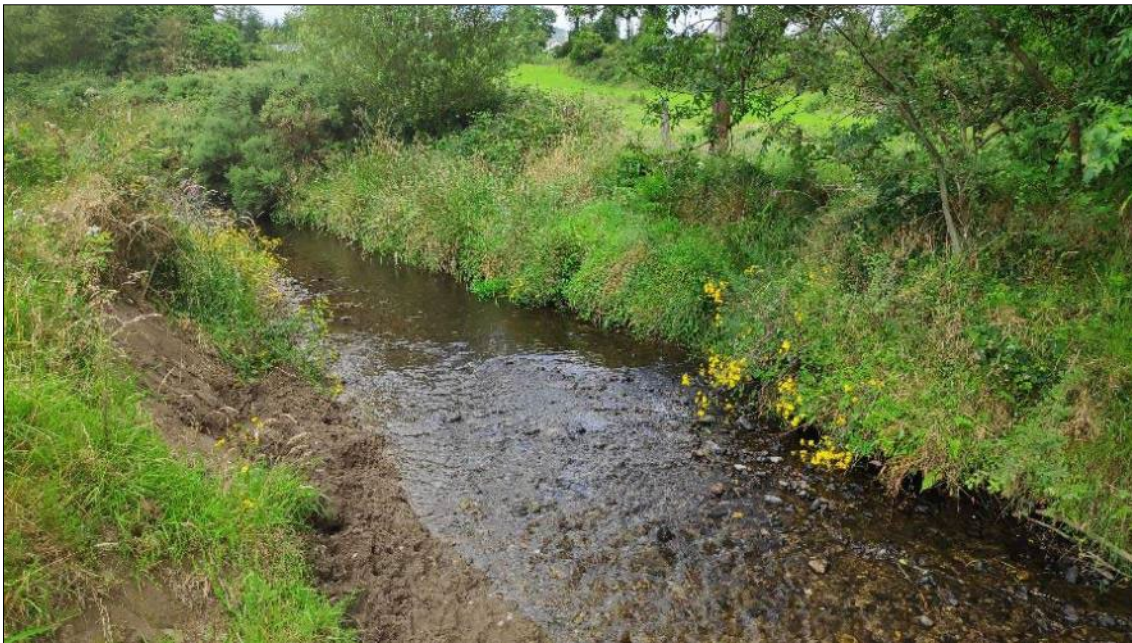
Biological water quality, based on Q-sampling, was calculated as Q3-4 (moderate status) (Table 7).

Plate 21: Representative image of site C5 on the Carrigthomas Stream downstream of Coppeleenbawn Bridge

Sites C5 (Carrigthomas Stream, Q3-4 moderate status) and C17 (Coolaniddane River, Q3 poor status) failed to meet the good status ($\geq Q4$) requirements of the European Union Environmental Objectives (Surface Waters) (Amendment) Regulations 2019 and the Water Framework Directive (2000/60/EC).

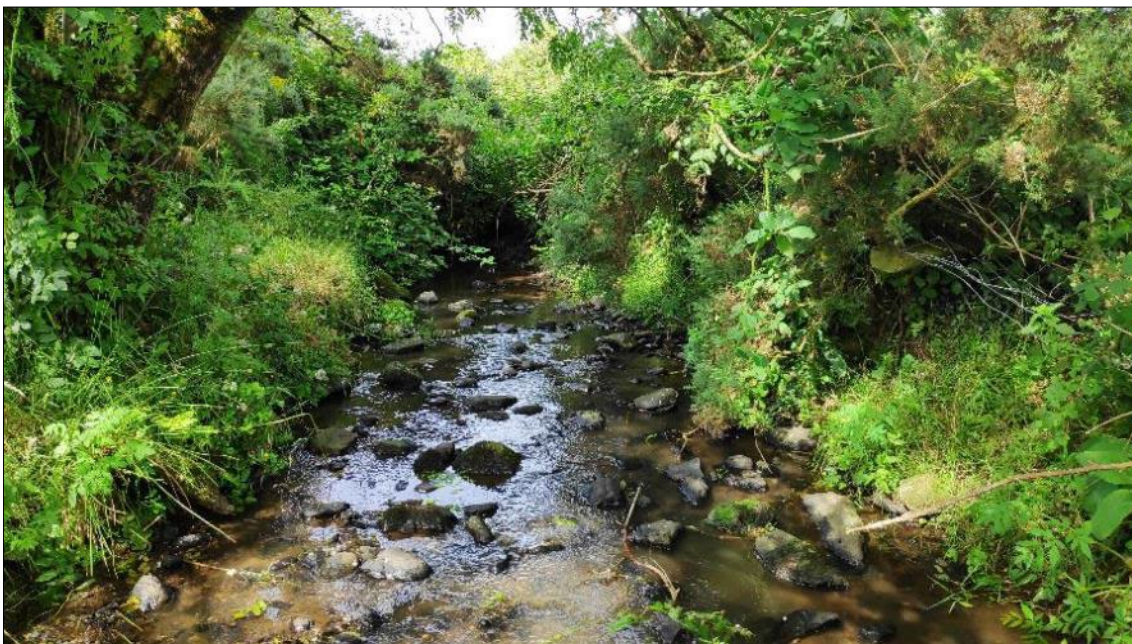
Brown trout was the only fish species recorded from site C6 via electro-fishing, with two small individuals captured. The site offered only moderate quality salmonid habitat, with a lack of deeper holding areas and only moderate quality nursery and spawning (siltation). European eel habitat was poor with none recorded via electro-fishing. Potential for lamprey existed but was low, with poor quality spawning substrata present (silted, bedded) and a lack of suitable sediment accumulations for larval burial. There was no suitability for freshwater pearl mussel. No white-clawed crayfish were recorded and there were no records for the species within the catchment. No otter signs were recorded during the survey and the site was considered of low suitability given its small size and shallow, high-energy nature.

Plate 22: Representative image of site C6 on an unnamed stream at Knocknagappul

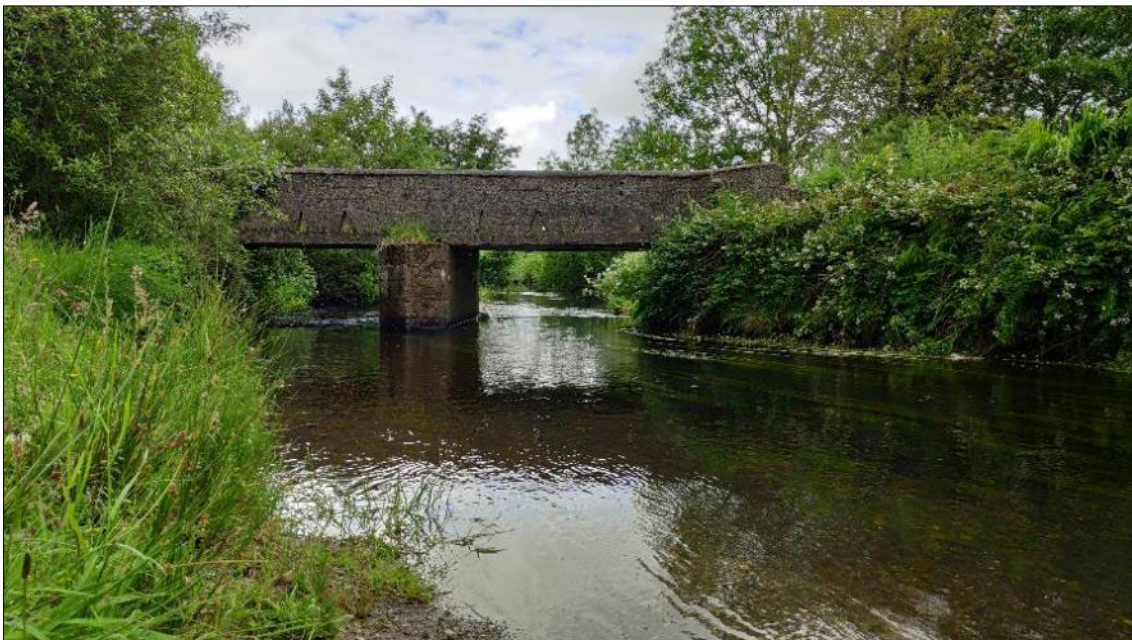
Brown trout was the only fish species recorded from site C7 via electro-fishing. Mixed cohorts of brown trout were present, ranging from juveniles to larger adults. Site C7 offered excellent salmonid habitat overall, with combinations of excellent spawning (clean, unbedded gravels and cobble), excellent nursery habitat (particularly in the vicinity of *Ranunculus* beds and upstream of the bridge) and excellent holding habitat for adults (downstream of the bridge). European eel habitat was considered good given the presence of instream refugia although none were recorded during electro-fishing. Whilst optimal larval lamprey habitat was not present, areas of sub-optimal sand-dominated substrata were present in marginal areas and in association with *Ranunculus* beds. However, no ammocoetes were recorded during electro-fishing. Lamprey spawning habitat was of moderate quality locally, particularly in marginal slacks downstream of the bridge where lower flows were more amenable to the species. There was some suitability for freshwater pearl mussel, although none were recorded in surveys throughout the River Laney. No white-clawed crayfish were recorded and there were no records for the species within the catchment. No otter signs were recorded during the survey but the site was considered of good suitability due to healthy salmonid population and good foraging habitat.

Biological water quality, based on Q-sampling, was calculated as Q4 (good status) (Table 7).

Plate 23: Representative image of site C7 on the River Laney at an unnamed bridge, Ballynagree West
