APPENDIX 2

Aquatic Ecology

Figure 1: Overview of the $n=40$ aquatic survey locations for the proposed Ballinagree wind farm project, Co. Cork.

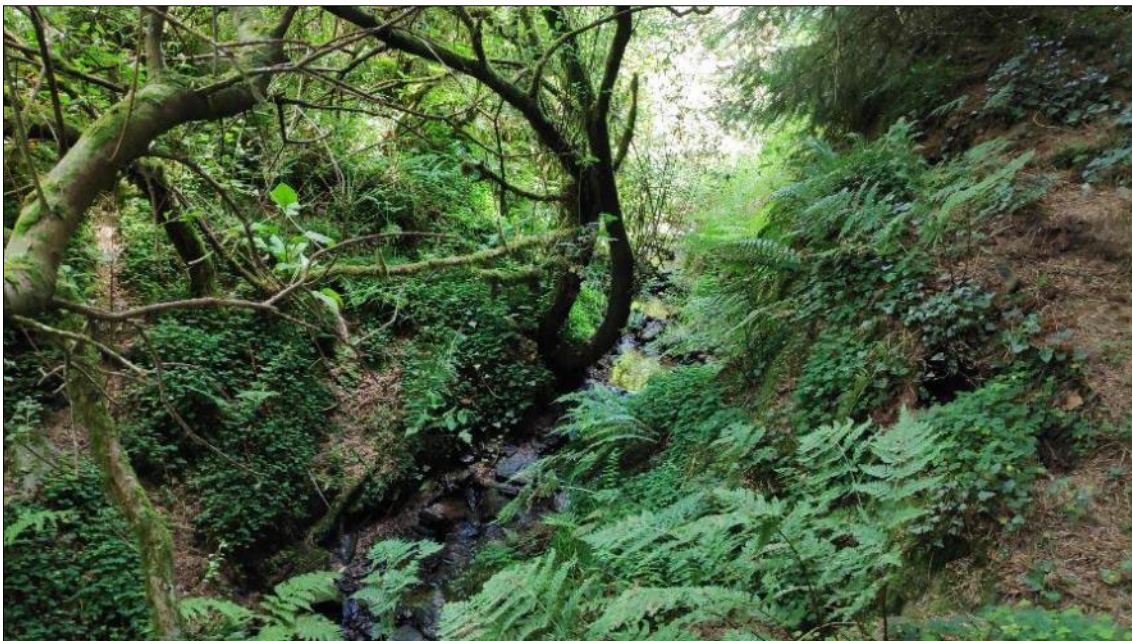
No fish were recorded from site C8 via electro-fishing. Site C8 offered no fisheries value at the time of survey and the channel was considered likely seasonal in its upper reaches, thus precluding resident fish. The site had no suitability for freshwater pearl mussel. No white-clawed crayfish were recorded and there were no records for the species within the catchment. No otter signs were recorded during the survey and the site was considered of low suitability given its small size and upland nature.

Plate 24: Representative image of site C8 on the Lacknahaghny Stream

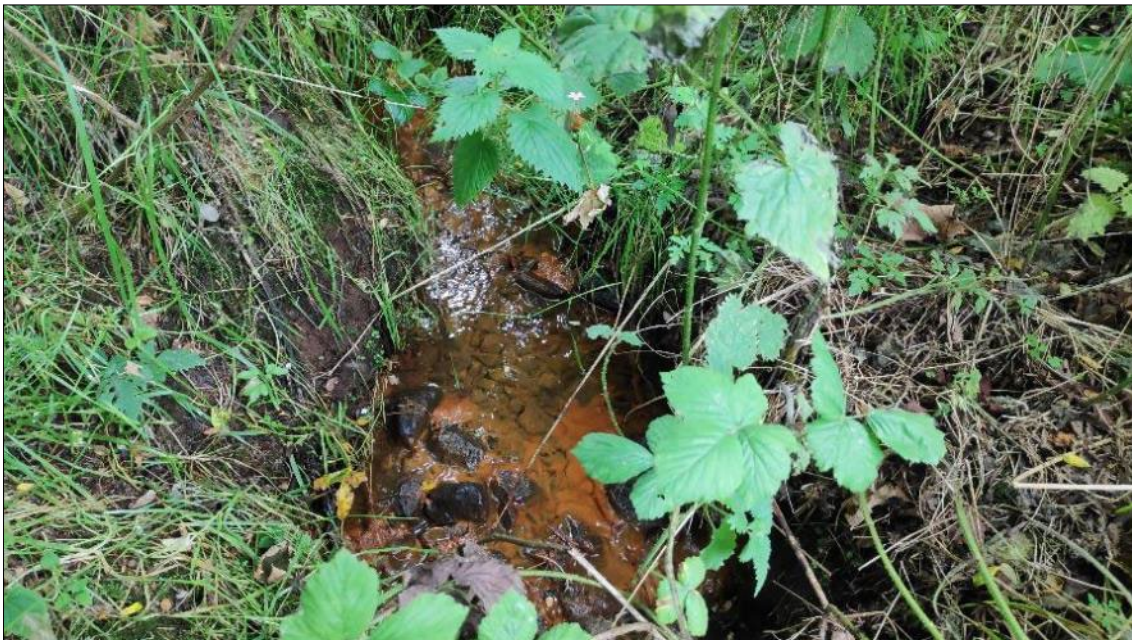
No fish were recorded from site C9 via electro-fishing. Site C9 offered no fisheries value at the time of survey and the channel was considered likely non-perennial in its upper reaches, thus precluding resident fish. The site had no suitability for freshwater pearl mussel or otter. No white-clawed crayfish were recorded and there were no records for the species within the catchment.

Plate 25: Representative image of site C9 on an unnamed stream at Carrigthomas

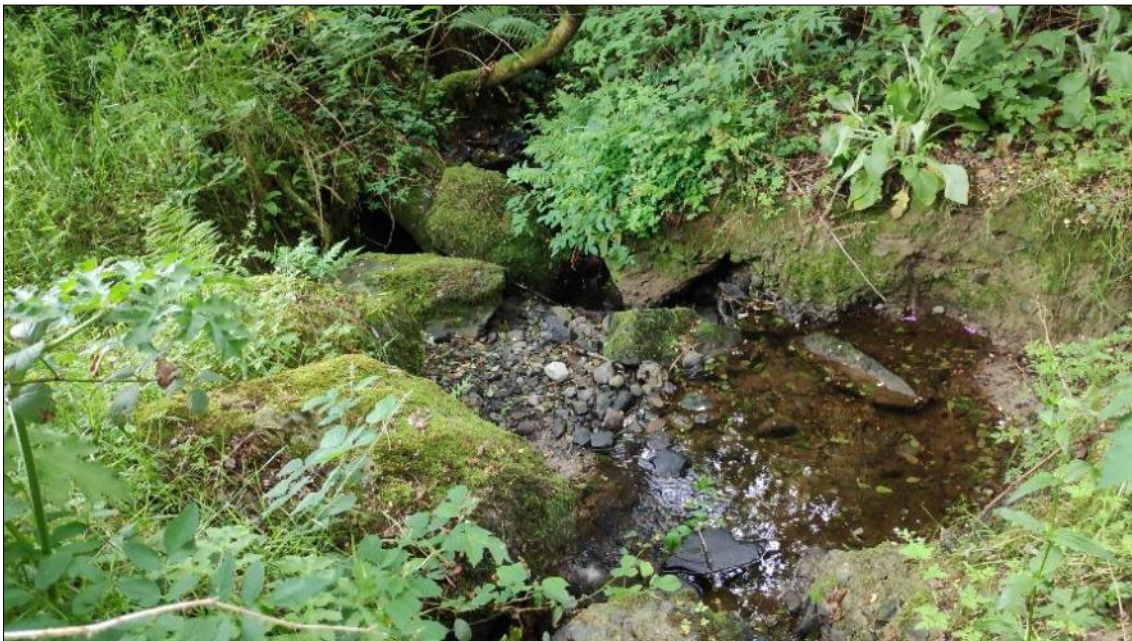
No fish were recorded from site C10 via electro-fishing. Site C10 offered very low fisheries value at the time of survey and the channel was considered likely non-perennial, thus precluding resident fish. However, some limited, sub-optimal habitat was present for salmonids and European eel further downstream nearer to the Laney confluence (more deeper pools). The upland eroding site was unsuitable for lamprey. The site had no suitability for freshwater pearl mussel. No white-clawed crayfish were recorded and there were no records for the species within the catchment. No otter signs were recorded during the survey and the site was considered of low suitability given its small size and upland nature.

Plate 26: Representative image of site C10 on an unnamed stream at Carrigthomas, immediately downstream of the road culvert

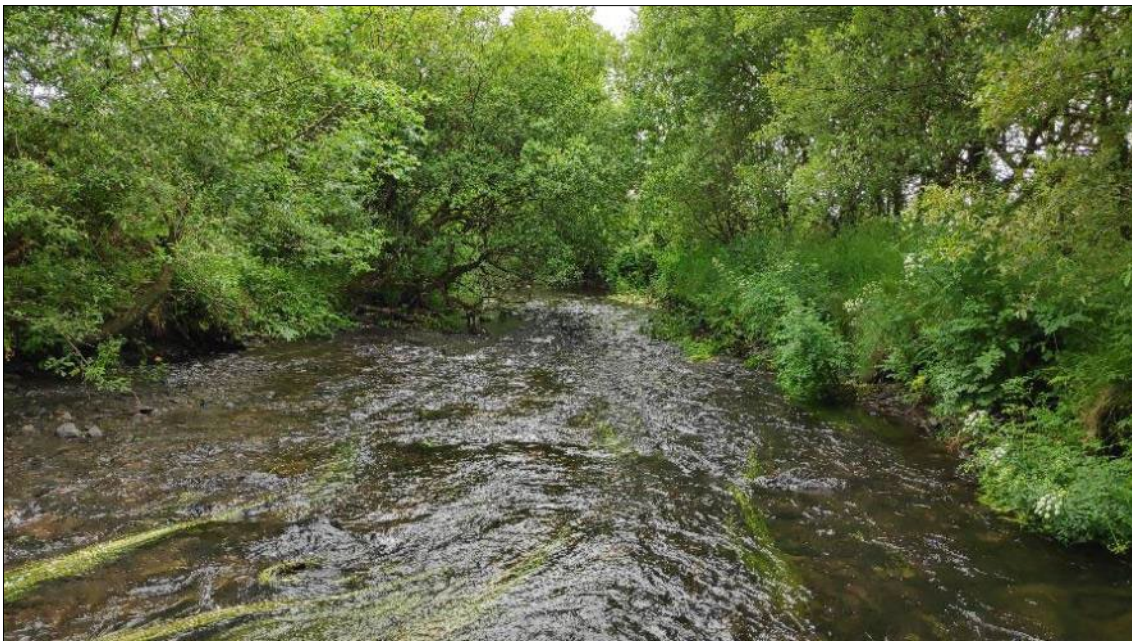
The site was considered of good value to European eel given the presence of deeper pool areas, scoured banks and large woody debris/boulder refugia in stream (however, none were recorded). Lamprey spawning habitat was present but localised (site more suited to salmonids) with sand-dominated sediment accumulations present locally in vicinity of the bridge and some instream *Ranunculus* beds (none recorded). There was some suitability for freshwater pearl mussel, although none were recorded in surveys throughout the River Laney. No white-clawed crayfish were recorded and there were no records for the species within the catchment. No otter signs were recorded in the vicinity of the bridge although the site had high suitability for the species given the presence of a healthy salmonid population and good foraging habitat.

Biological water quality, based on Q-sampling, was calculated as Q4 (good status) (Table 7).

Plate 27: Representative image of site C11 the River Laney at Knocknagappul Bridge (facing downstream from bridge)

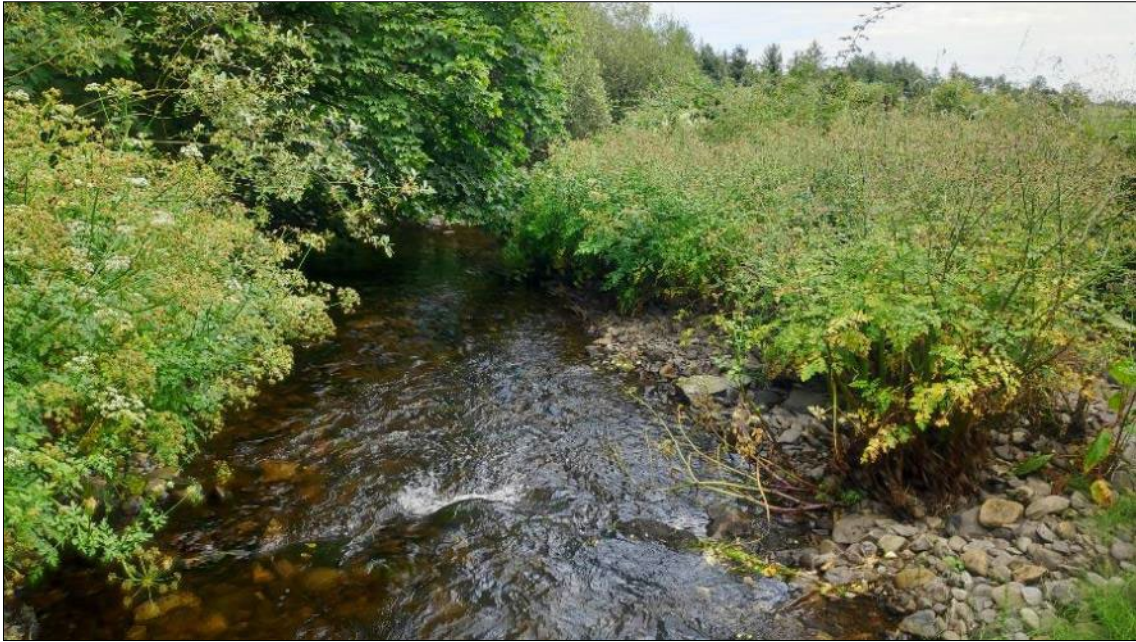
Brown trout was the only fish species recorded from site C12 via electro-fishing. Moderate numbers of mixed cohort brown trout were present, ranging from juveniles to larger adults. The site was evidently a good salmonid habitat, with good quality spawning, nursery and holding habitat present. Despite some good European eel suitability, particularly in vicinity of the bridge and in deeper pools, none were recorded. The high energy of the site and lack of sediment deposition precluded larval lamprey, despite some localised spawning habitat in slacker areas. No freshwater pearl mussels were recorded at this site. No white-clawed crayfish were recorded and there were no records for the species within the catchment. No otter signs were recorded during the survey but the site had high suitability for the species given the presence of a healthy salmonid population and good foraging habitat.

Biological water quality, based on Q-sampling, was calculated as Q4 (good status) (Table 7).

Plate 28: Representative image of site C12 the Awboy River at Awboy Bridge (facing downstream from bridge)

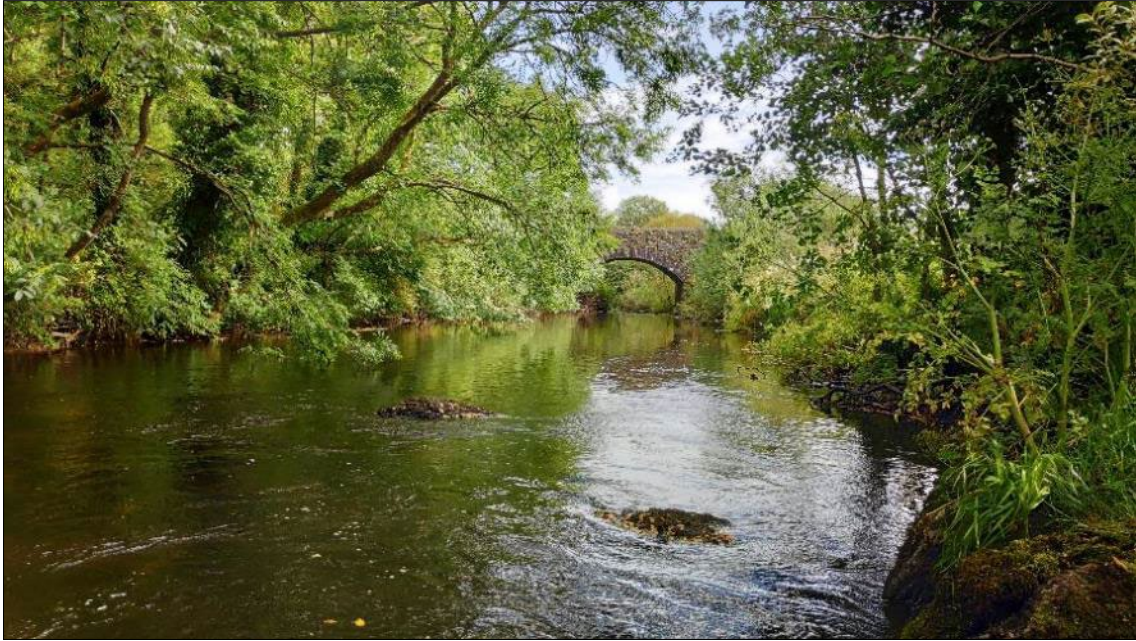
No white-clawed crayfish were recorded and there were no records for the species within the catchment. No otter signs were recorded during the survey but the site had high suitability for the species given the presence of a healthy salmonid population and good foraging habitat.

Biological water quality, based on Q-sampling, was calculated as Q4 (good status) (Table 7).

Plate 29: Representative image of site C13 the River Laney at Clonavrick Bridge (facing back upstream towards bridge)

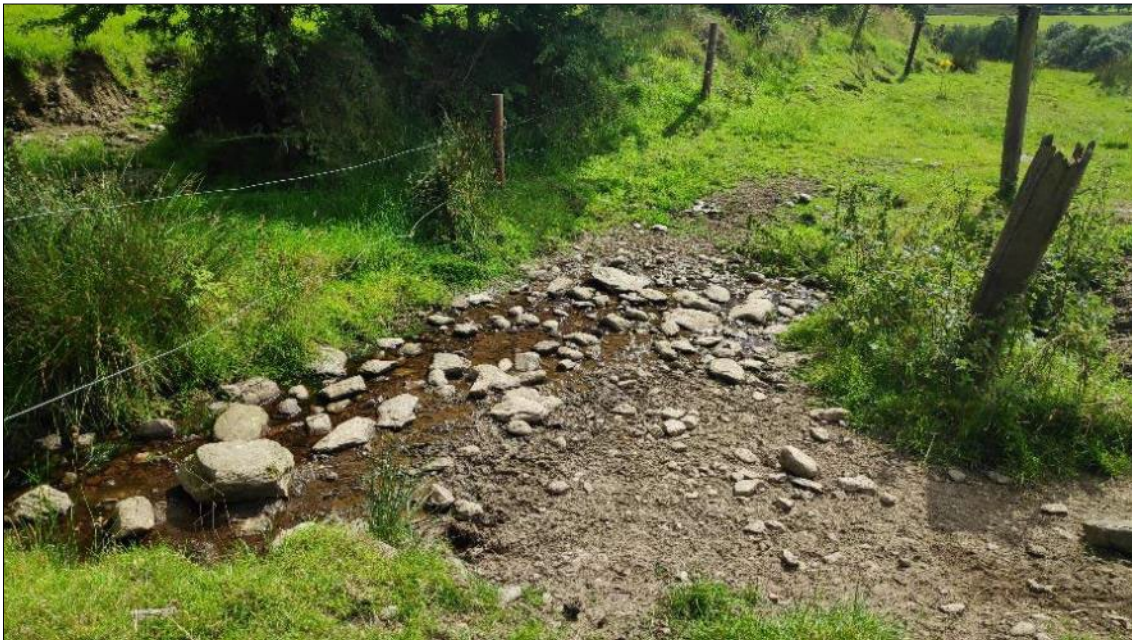
No fish were recorded at site C14 via electro-fishing and the site was not of fisheries value at the time of survey given the lack of water and evidently poor water quality (i.e., siltation, enrichment etc.). However, fisheries habitat improved further downstream nearer the Laney confluence. There was no suitability for freshwater pearl mussel or white-clawed crayfish. No otter signs were recorded during the survey and the site was considered of low suitability given its small size.

Plate 30: Representative image of site C14 the Clonavrick Stream (downstream of road culvert)

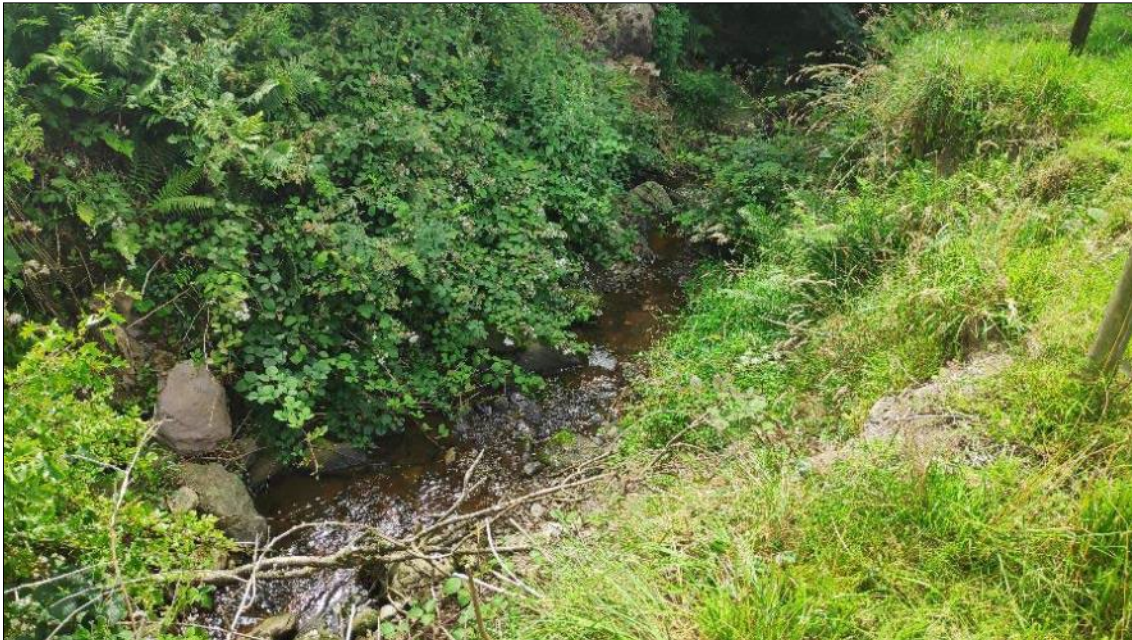
No fish were recorded at site C15 via electro-fishing, despite some physical habitat suitability. Whilst the foul odour present upstream (agricultural run-off) was not present downstream, enrichment was evident and it appeared upstream agricultural pressures had impacted the fisheries habitat of the river. Thus, the site had very poor fisheries value. Irrespectively, European eel habitat was poor given the small, shallow nature of the site. The higher energy and lack of suitable sediment accumulations precluded the presence of lamprey. There was no suitability for freshwater pearl mussel or white-clawed crayfish given the site characteristics. No otter signs were recorded during the survey and the site was considered of low suitability given its small size.

Plate 31: Representative image of site C15 on the Coolaniddane River (downstream of road culvert)

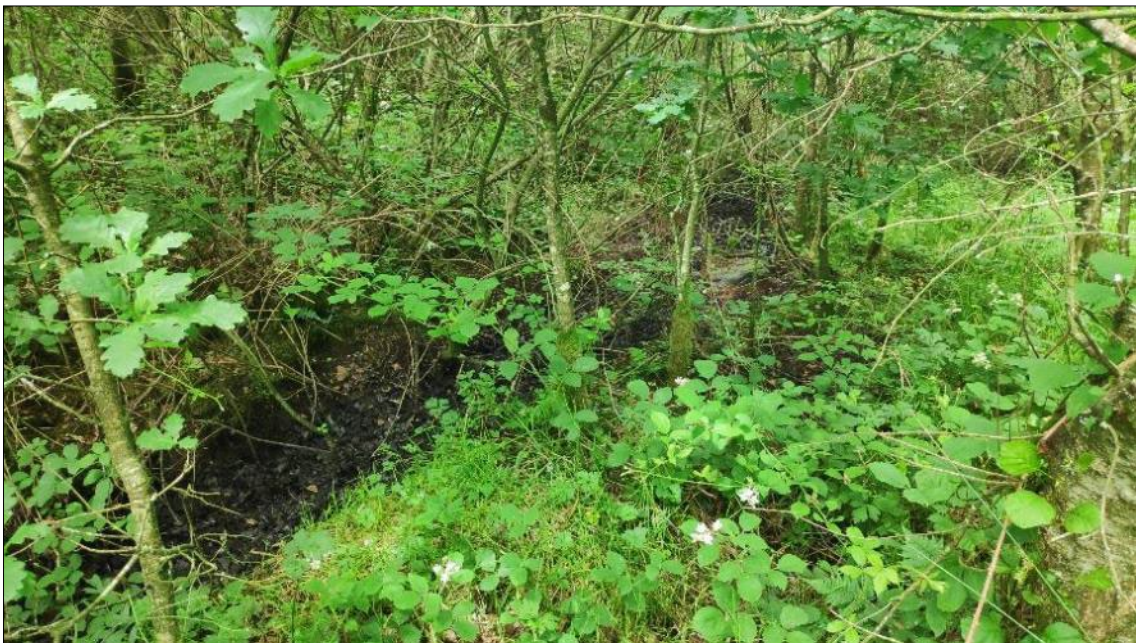
No fish were recorded at site C16 and the site had no fisheries value at the time of survey given the lack of water or flow. Being located in the uppermost reaches, with no connectivity to other watercourses nearby, the site was considered unlikely to serve as a migratory pathway for European eel. There was no suitability for freshwater pearl mussel, otter or white-clawed crayfish given the site characteristics.

It was not possible to assess biological water quality at this site given a lack of water and flow.

Plate 32: Representative image of site C16 on the Kilberrihert Stream (downstream of road culvert)

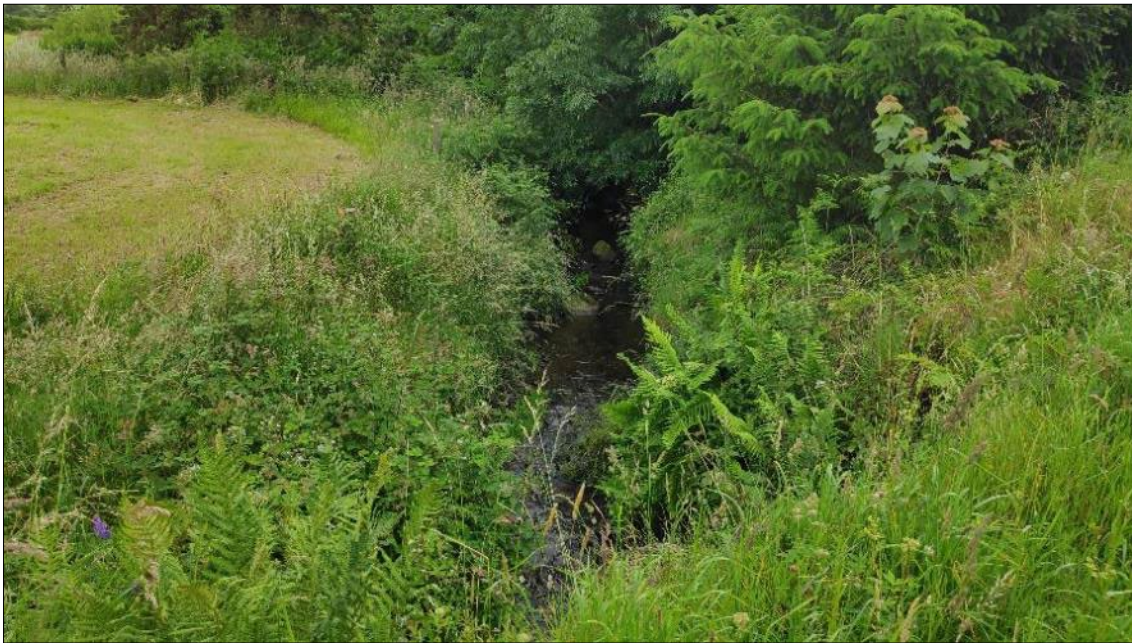
Biological water quality, based on Q-sampling, was calculated as Q3 (poor status) (Table 7). The site failed to meet the EPA nitrate threshold for good status water quality (i.e., very high TON of 2.489mg N/l) (Table 9).

Plate 33: Representative image of site C17 the Coolaniddane River (upstream of road culvert)

Sites C5 (Carrigthomas Stream, Q3-4 moderate status) and C17 (Coolaniddane River, Q3 poor status) failed to meet the good status ($\geq Q4$) requirements of the European Union Environmental Objectives (Surface Waters) (Amendment) Regulations 2019 and the Water Framework Directive (2000/60/EC).

The majority of survey locations featured low alkalinity, circum-neutral pH, low MRP and low to moderate total oxidised nitrogen (TON) levels (Table 9). However, TON was particularly high at sites C17 and B10 (failed to meet EPA's threshold for good status). Levels of molybdate reactive phosphorus (MRP) were particularly high at site A1, with the site failing to meet the good status threshold set out under S.I. No. 77/2019 - European Union Environmental Objectives (Surface Waters) (Amendment) Regulations 2019.

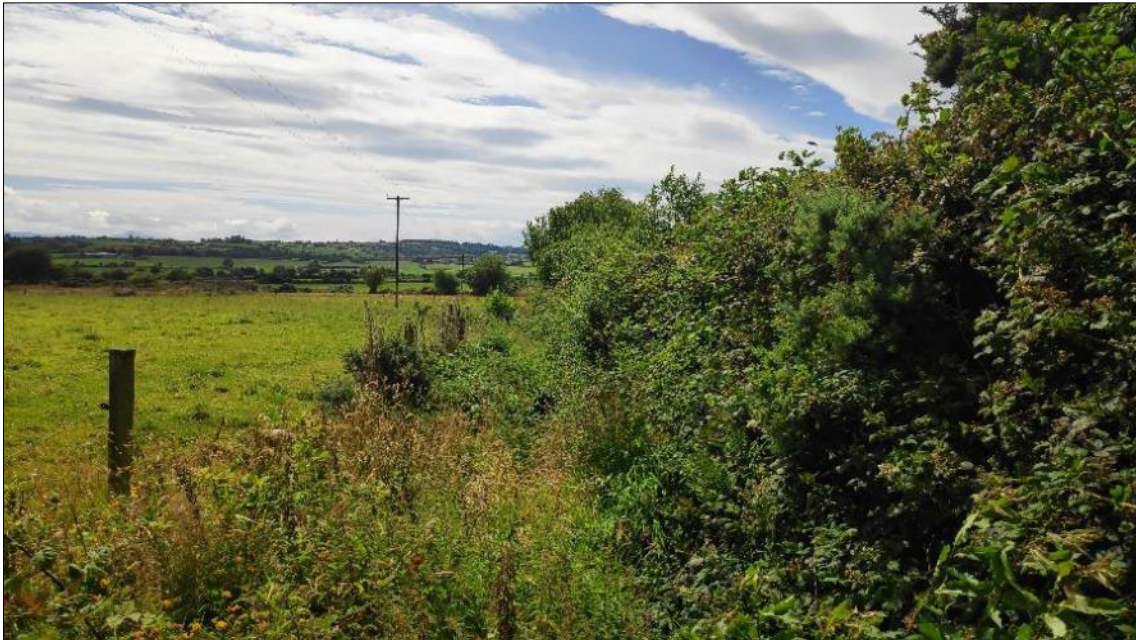
No fish were recorded at site C18 via electro-fishing and site had no fisheries value at the time of survey given the lack of water or flow. Being located in the uppermost reaches, with no connectivity to other watercourses nearby, the site was considered unlikely to serve as a migratory pathway for European eel. There was no suitability for freshwater pearl mussel, otter or white-clawed crayfish given the site characteristics.

Plate 34: Representative image of site C18 the Caherbaroul Stream (downstream of road culvert, heavily bound in scrub)

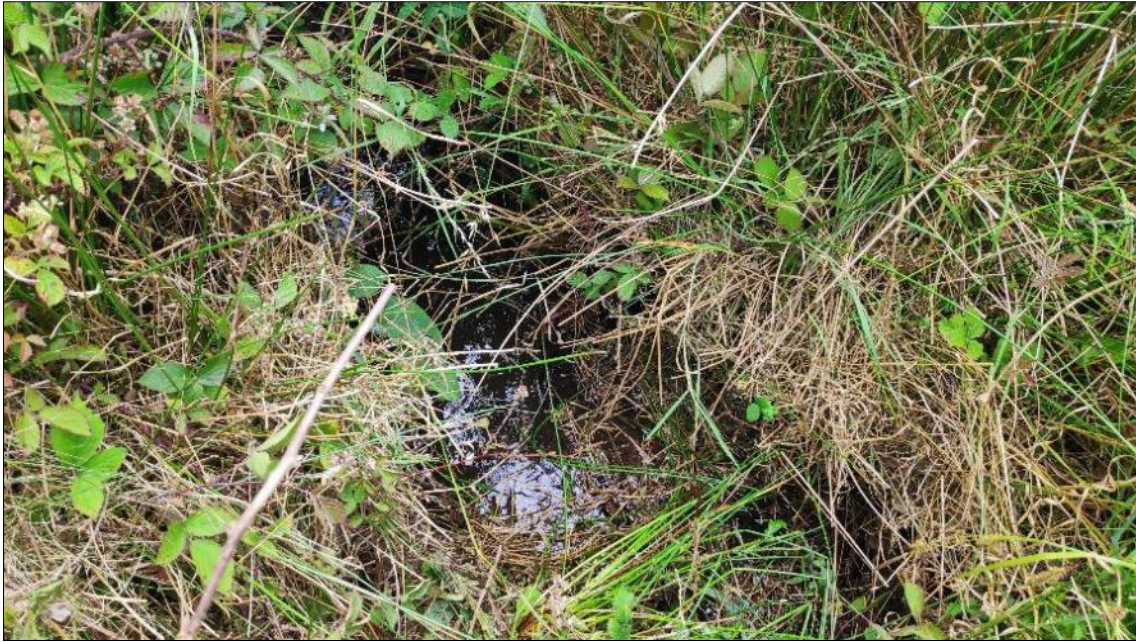
Being located in the uppermost reaches, with no connectivity to other watercourses nearby, the site was considered unlikely to serve as a migratory pathway for European eel. There was no suitability for freshwater pearl mussel, otter or white-clawed crayfish given the site characteristics.

Plate 35: Representative image of site C19 the Bealick Stream (semi-dry channel, localised ponding only)

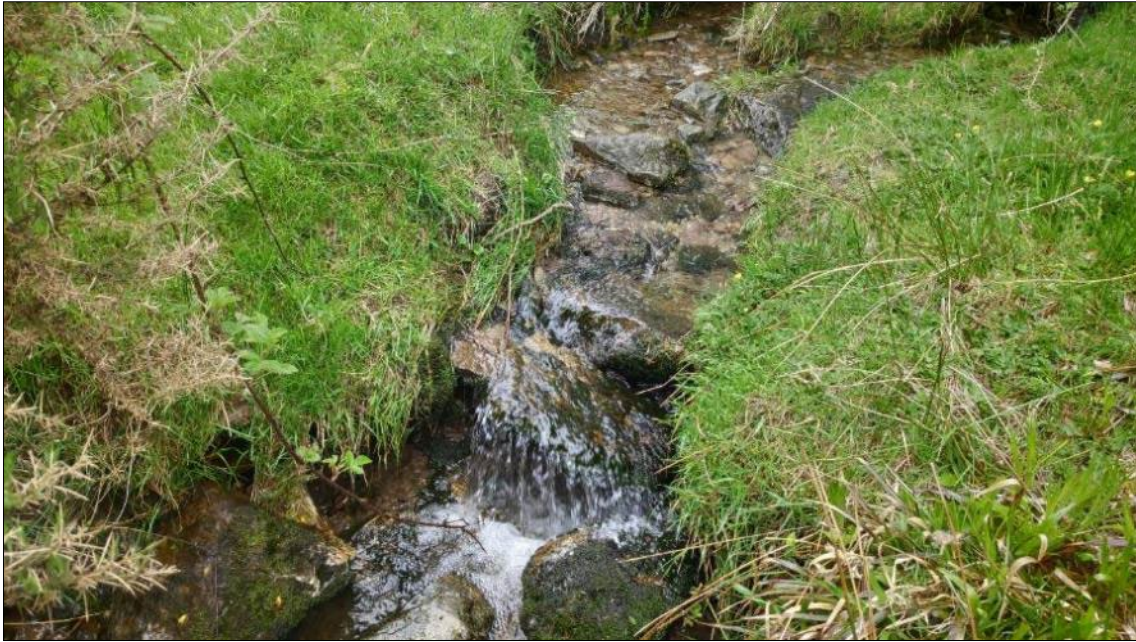
Whilst a Q-sample was taken in June 2021, the paucity of macro-invertebrates recorded (very low numbers of Tubificidae larvae and *Lumbriculus* sp.) was not sufficient to reliably calculate water quality status (Table 8). This was presumably an artefact of the non-perennial nature of the stream.

Plate 36: Representative image of site N1 on the West Ballynagree Stream at proposed watercourse crossing WF-HF5

At site N1 on the West Ballynagree Stream (watercourse crossing WF-HF5) a low number of macro-invertebrate individuals and species was recorded (i.e., very low numbers of Tubificidae larvae and *Lumbriculus* sp. were recorded present). This community composition was not sufficient to reliably calculate water quality status and was considered an artefact of the non-perennial nature of the stream.

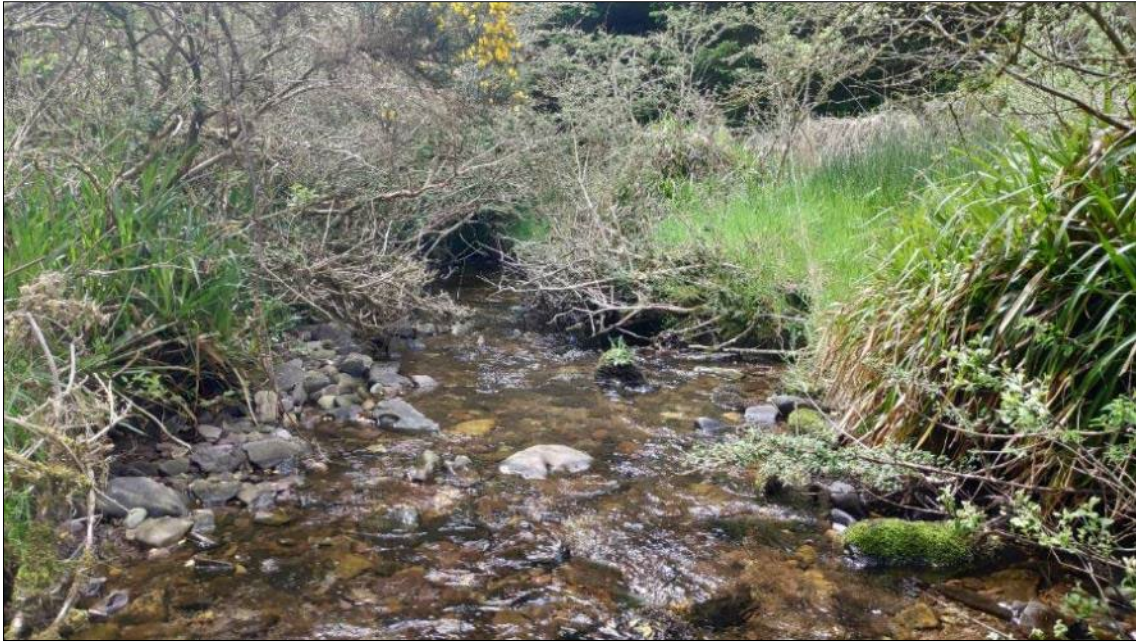
An electro-fishing survey was not undertaken at this site (i.e., fisheries appraisal only). The River Laney at site N2 (proposed pre-cast box culvert) was a moderate-quality salmonid habitat with some locally good spawning habitat. Holding pools for larger adults was sparse. The site was most of value as a brown trout nursery. European eel habitat was moderate given the site characteristics and their presence would have been inhibited by the presence of downstream hydro-electric dams. There was no potential for white-clawed crayfish. Freshwater pearl mussel were not recorded and the species is not known from the River Laney, despite some physical habitat suitability. No otter signs were recorded during the survey and the site was considered of low suitability given its small size and upland nature.

Biological water quality, based on Q-sampling, was calculated as Q4 (good status) (Table 8).

Plate 37: Representative image of site N2 on the upper River Laney at proposed watercourse crossing WF-HF6

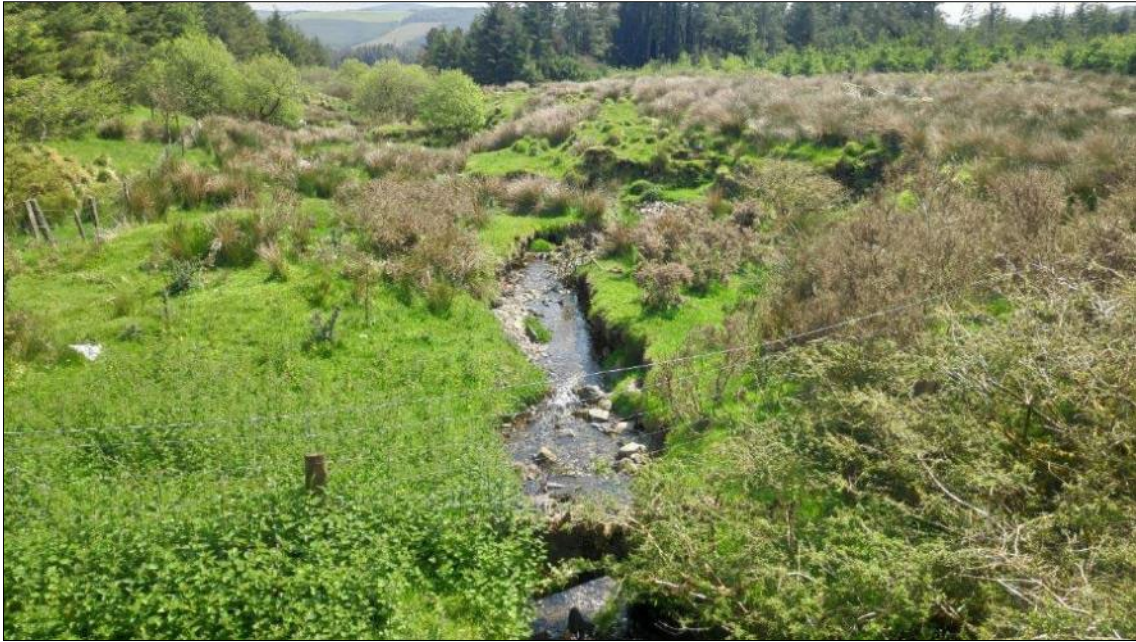
An electro-fishing survey was not undertaken at this site (i.e., fisheries appraisal only). Site N3 was located in the headwaters of the small unnamed stream and thus was of low fisheries value. The high-gradient spate channel was considered likely exposed to low flows during summer months and this, coupled with natural and artificial barriers on the watercourse, likely precluded fish presence (however, some low eel potential, in season). The box culvert under road acted as an impassable barrier to fish, with a 2m fall. There was no suitability for white-clawed crayfish or freshwater pearl mussel. No otter signs were recorded during the survey and the site was considered of low suitability given its small size and upland nature.

Biological water quality, based on Q-sampling, was calculated as Q4-5 (high status) (Table 8).

Plate 38: Representative image of site N3 on the upper reaches of a small unnamed River Laney tributary at proposed watercourse crossing WF-HF8 (facing downstream from road crossing)

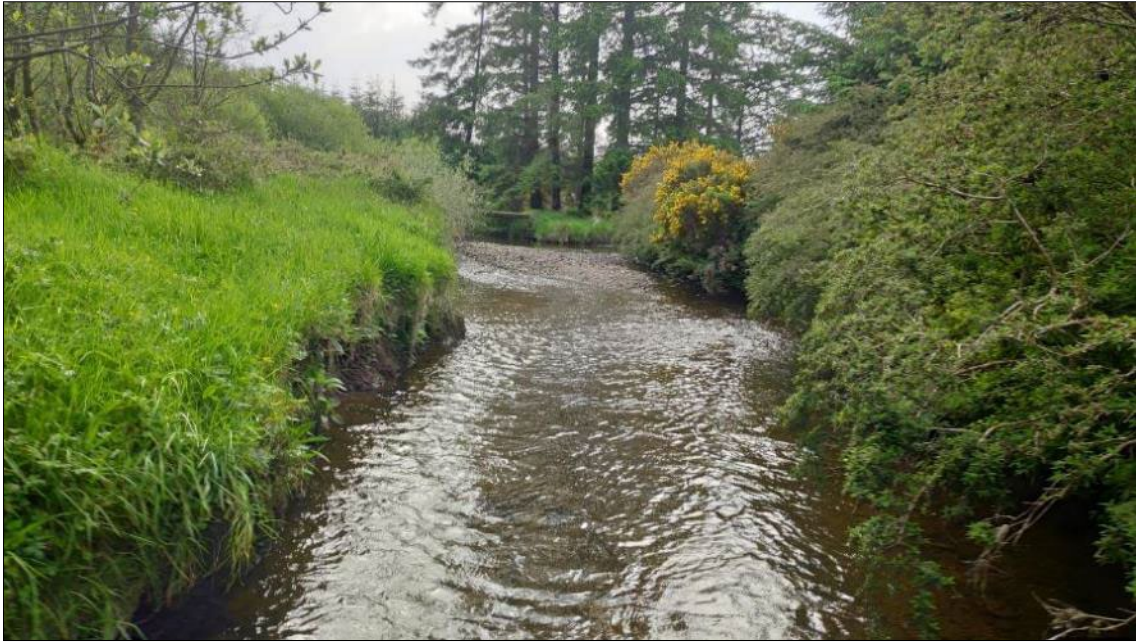
An electro-fishing survey was not undertaken at this site (i.e., fisheries appraisal only). Site N4 was evidently of high value to salmonids with excellent quality spawning and nursery habitat present, in addition to some localised deeper holding pools and undercuts for larger adults. European eel habitat, whilst present, was sub-optimal given the general paucity of suitable refugia (e.g., larger boulders). Although some sand accumulations were present marginally, these were unsuitable for larval lamprey and the general upland eroding (higher-energy) nature of the site likely precluded the presence of *Lampetra* sp. The substrata were generally considered to be too mobile for freshwater pearl mussel and, irrespective of some habitat suitability, the species is not known from the River Laney. No otter signs were recorded during the survey but the site was considered of moderate suitability given the presence of a healthy salmonid population.

Biological water quality, based on Q-sampling, was calculated as Q4 (good status) (Table 8).

Plate 39: Representative image of site N4 on the upper reaches of the River Laney at proposed watercourse crossing WF-HF4 (facing upstream to existing ford crossing)

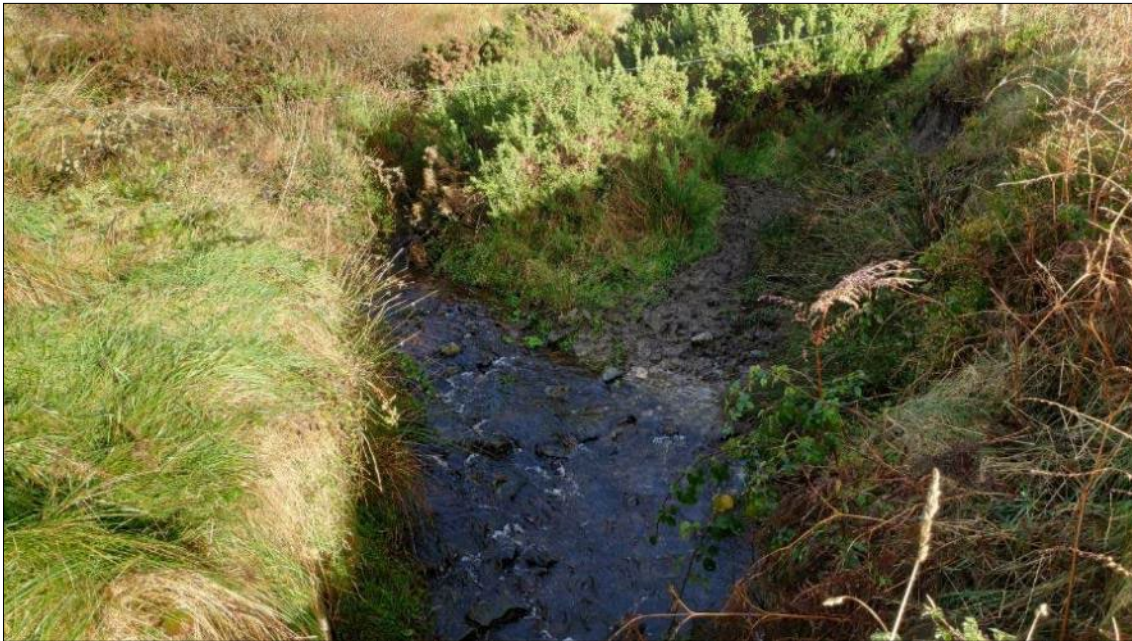
An electro-fishing survey was not undertaken at this site (i.e., fisheries appraisal only). The site was of moderate value as a salmonid nursery and spawning habitat (brown trout only). Holding habitat for adults was (typically for a small stream) present but limited in distribution and extent. Salmonid habitat improved in the downstream-connecting Carrigthomas Stream. Whilst some finer gravels suitable for *Lampetra* sp. spawning were present, there was no suitable ammocoete habitat given the high energy nature of the site. European eel habitat was moderate overall given the high energy of the site and paucity of optimal refugia. The site had low suitability for white-clawed crayfish and none were recorded. There was no suitability for freshwater pearl mussel given the small, shallow size of the stream. No otter signs were recorded during the survey and the site was considered of low suitability given its small size and high-energy nature.

Biological water quality, based on Q-sampling, was calculated as Q4 (good status) (Table 8).

Plate 40: Representative image of site N5 on an unnamed, unmapped stream at proposed watercourse crossing GCR-WCC19
