Freshwater Pearl Mussel Survey
Report

FRESHWATER PEARL MUSSEL (*Margaritifera margaritifera*) SURVEY
IN WATERCOURSES DOWNSTREAM OF
BALLINAGREE WINDFARM SITE

23 July 2020

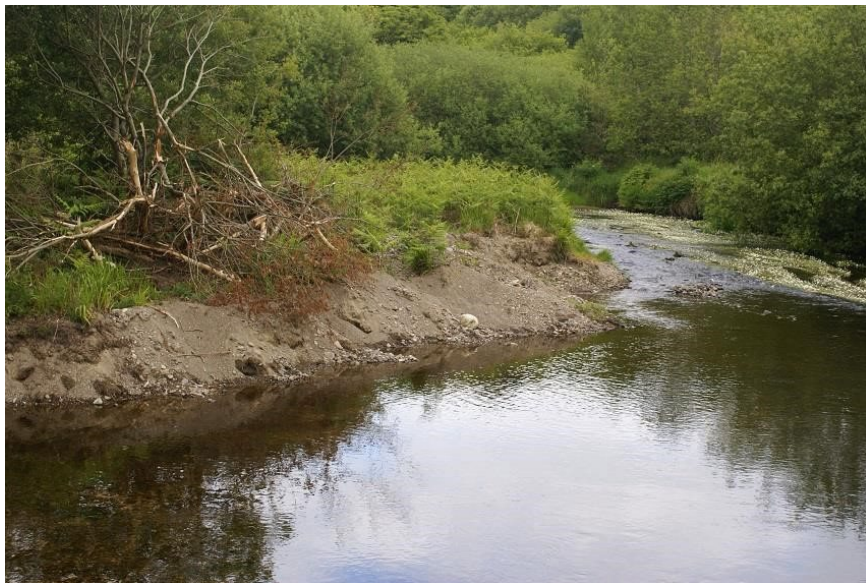
3: Dredging and bank works at Site FPM2 upstream

Dredging and bankside clearance: This was observed in the upstream section of site FPM2 (see Photo 3).

The loss of the small population of freshwater pearl mussels from the River Laney is likely to be at least partly due to the amount of silt observed. Three possible sources of silt are considered: Forestry: An increase in suspended sediment loadings in rivers can occur during forestry operations (Allott et al., 2005).

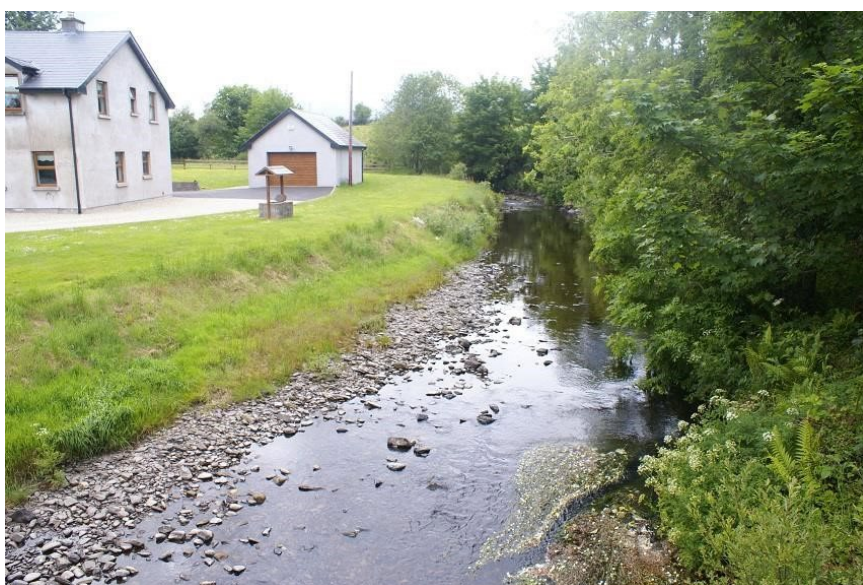
Photo 6: Site FPM4, Awboy river

The Awboy River, which would be crossed by one of the cable route options, does not have sufficient flow to support freshwater pearl mussels. The habitat in the River Laney should be excellent for mussels. However, the amount of silt present is greater than would be expected in a river of this type.

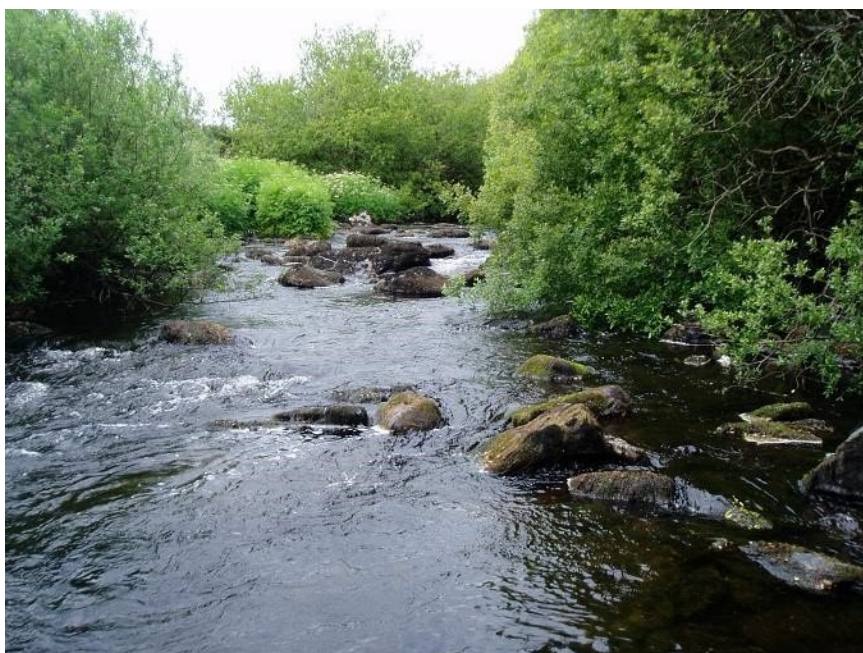
Photo 9: Pet food cans in the river downstream of Clonavrick Br.

Another damaging activity to the River Laney is dumping. There are thousands of pet food cans in the river, dumped in from Clonavrick Bridge, where there is a considerable concentration of them, many still with paper labels intact (see Photo 9). Cans can be found all the way down to the confluence of the River Laney with the Sullane River.
